WILDFIRE AND RIVER RESTORATION CHEWUCH RIVER, WASHINGTON

WILDFIRE HISTORY

WILDFIRE EFFECTS ON RESTORATION

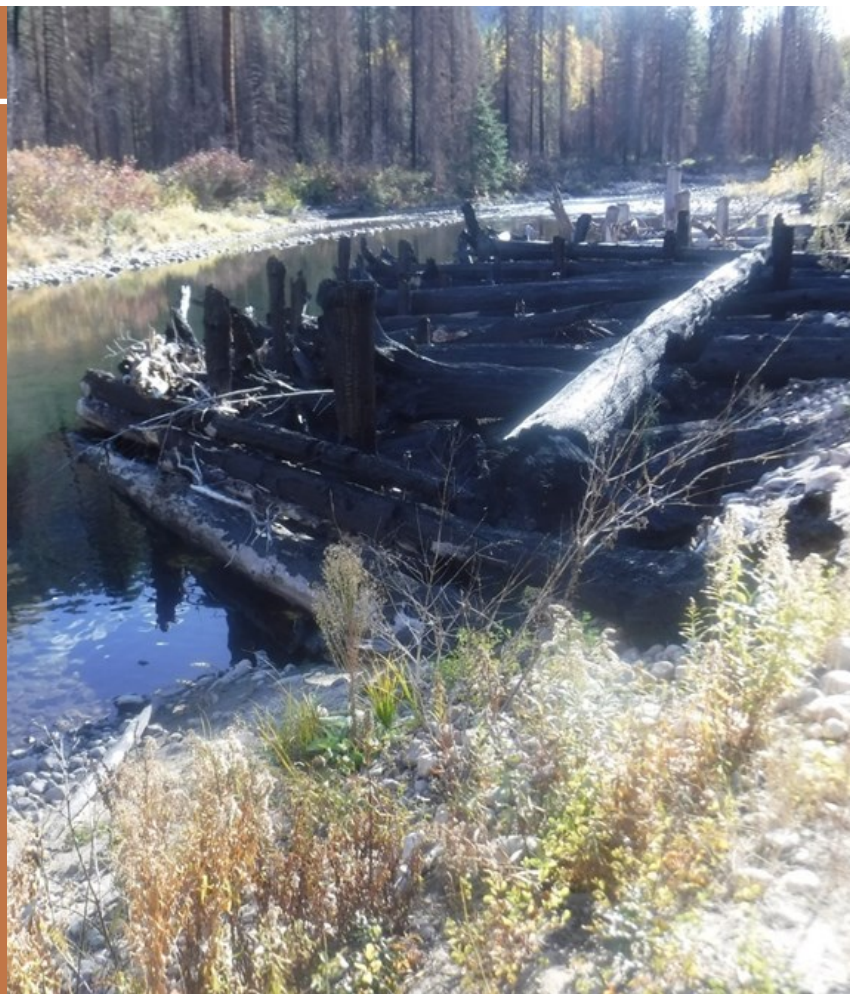
2015 Restoration, Site Q

- Buried large wood structure remained similar in shape and function until fire
- Structure still has structural integrity
- Alluvial fan and structure partially buried by mudflow
- Mudflow generated in a steep, severely burned side drainage.

2017 Restoration, Sites B, E, and J

- Inlet apex structure and significant pieces of jam burned, but base layer did not
- Reduced structural integrity and strength at all sites; risk that portions of jams will mobilize during future flows
- Logs, piles, and other key pieces have smaller diameters (some down to 12 inches)
- Some pools and habitat remain after fire

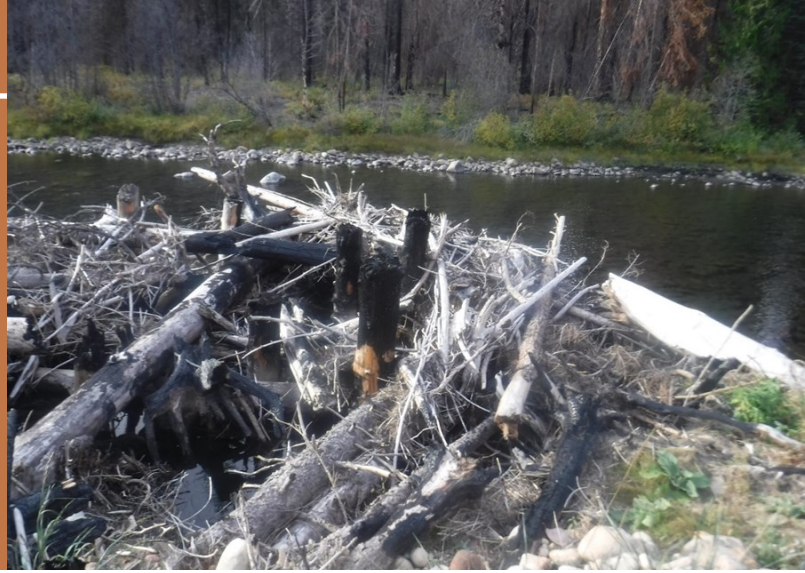
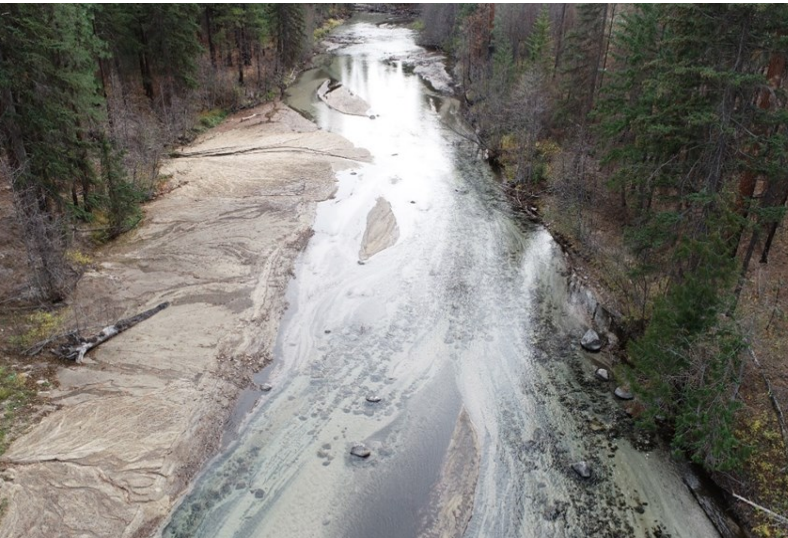
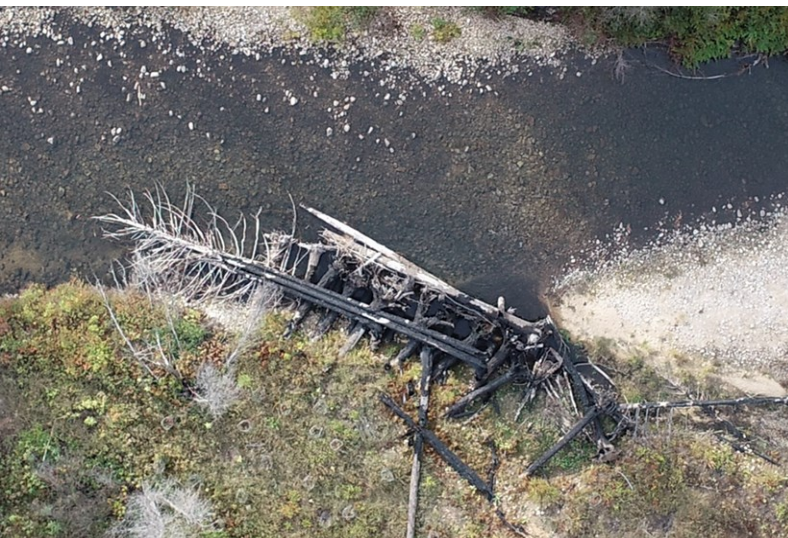
2018 Restoration, Sites L, M, N, and P

- All sites featured pile-ballasted large wood structures extending into channel
- Most of slash and log jam components consumed
- Design integrity lost; possible remaining portions will be removed by future flood flows
- Bottom layers largely remain intact and may collect wood from upstream over time
- Some habitat still maintained after fire
- Largest diameter classes of wood maintained design stability and continues to function and cultivate habitat

- Bank buried and pile ballasted structures with limited projection into the active channel were particularly susceptible to burning. Increasing submergence of the structure would increase resiliency to burning.

- Logs ballasted with alluvium remained part of a structure that did burn and lose wood mass, suggesting a need to build lower elevation structures in greater contact with wetted channel.

- Structures that used larger diameter wood material better withstood burn periods and had more material left unburned after the fire; they were also more able to remain viable and positively impact post-fire habitat.

- Structures with larger volumes of slash burned easier, longer, and ignited more of the larger diameter structural pieces than those without much slash. Distribution of slash within structures should be considered in fire-prone projects.
