Wildfire and River Restoration: Case Studies from the Methow River Watershed

For U. S. Bureau of Reclamation
July 2023

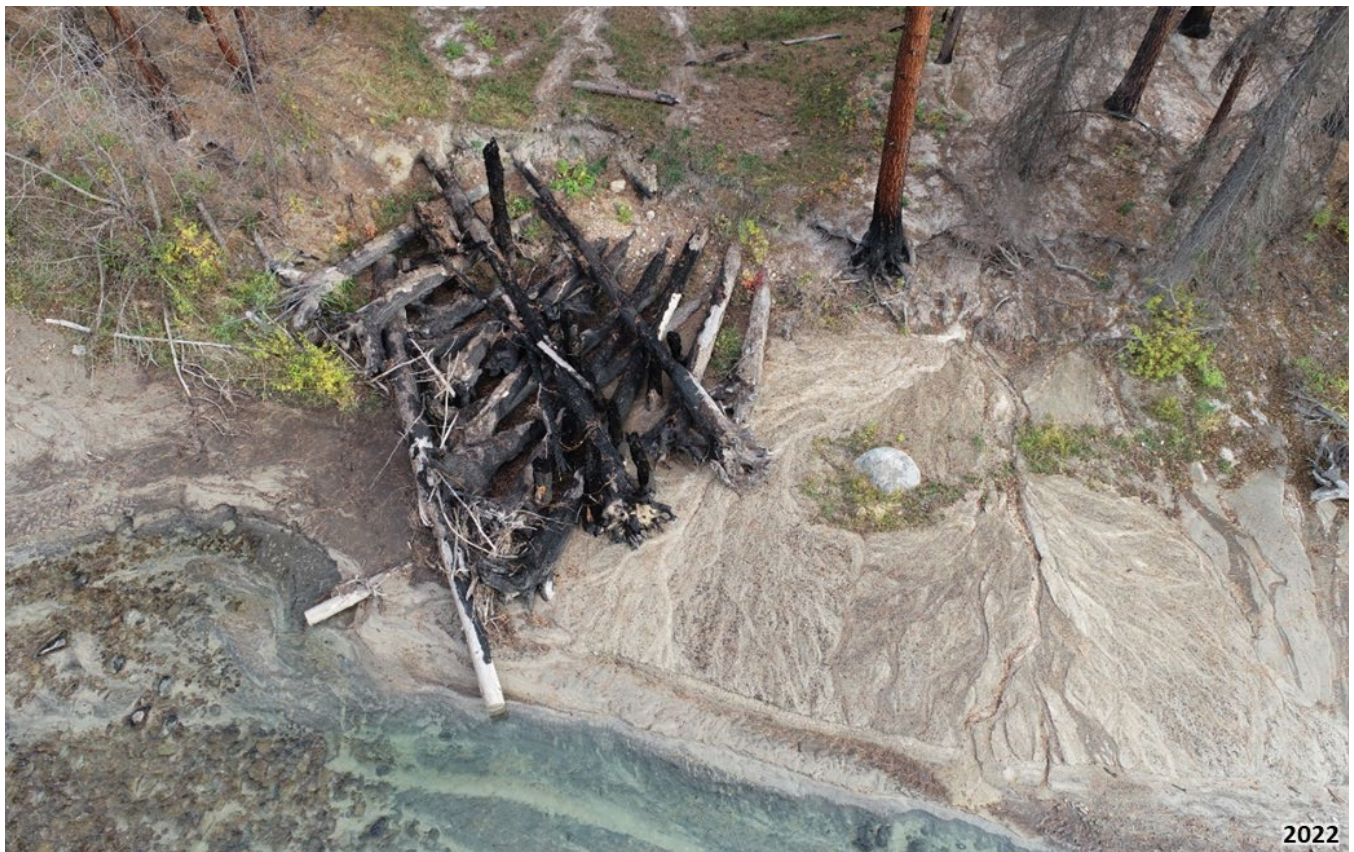
Site Q was a left-bank-buried large wood structure that extended 20 feet into the channel. It was constructed in 2015 and remained similar in shape and function until the Cub Creek 2 Fire, which burned most of the exposed wood in the structure. However, the burn was largely superficial and the wood in it remains structurally sound. Therefore, the post-fire structure has retained all of its post-project stability. One year after the fire, the alluvial fan and structure was partially buried by a mudflow deposit emanating from the LeRoy Creek watershed. The precipitation event and timing of the mudflow is unknown, but a significant volume of mud, boulders, and debris inundated the fan and Chewuch River. The mudflow was generated in a steep, severely burned side drainage previously mapped as high risk by the USGS following the Cub Creek 2 Fire. See Figure 3-7, Figure 3-8, and Figure 3-9 for images of Site Q after the debris flow.

Figure 3-7. Site Q post-fire and post-debris flow.

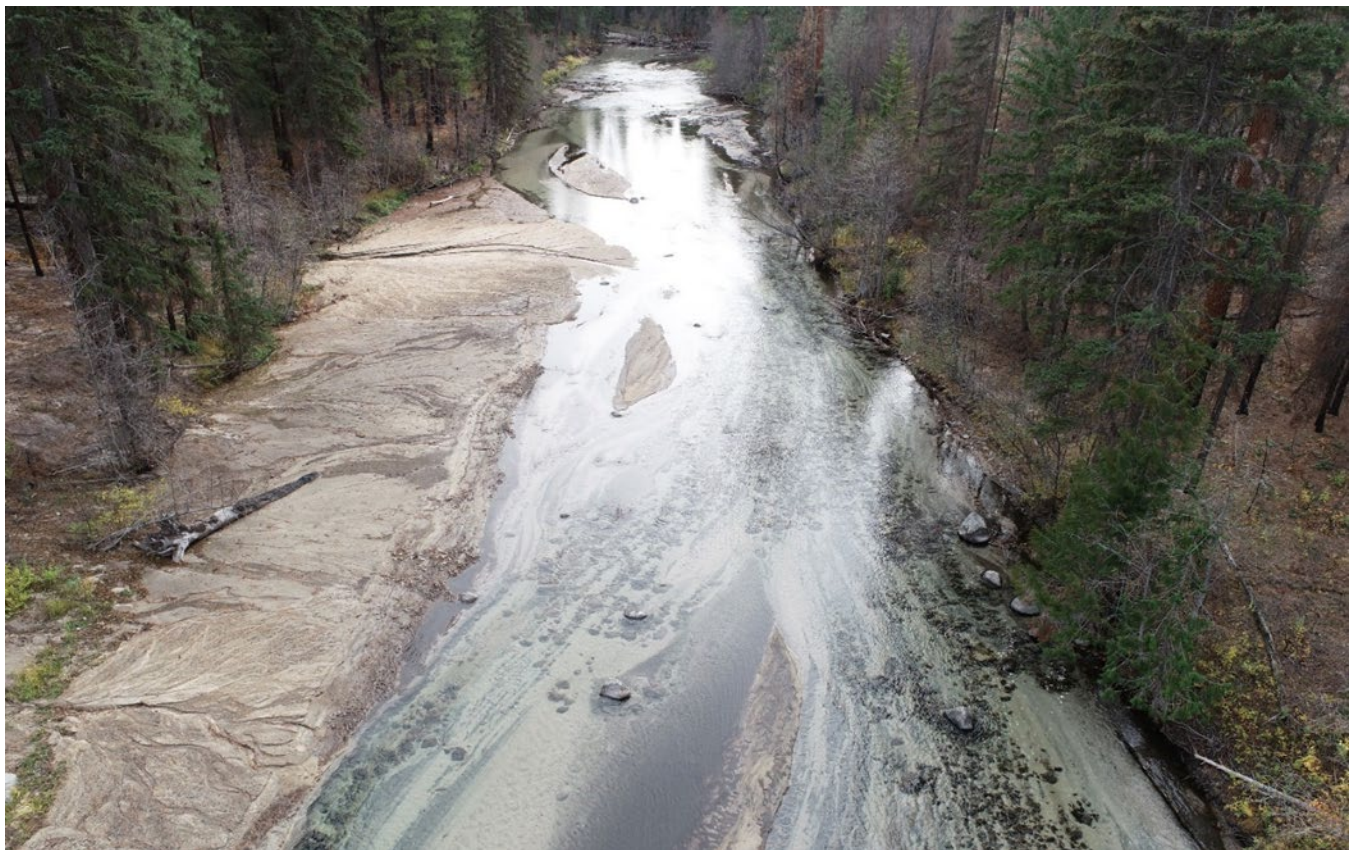
Figure 3-8. Leroy Creek debris flow runout within the channel of the Chewuch River. The Leroy Creek debris flow entered the Chewuch River on river left.

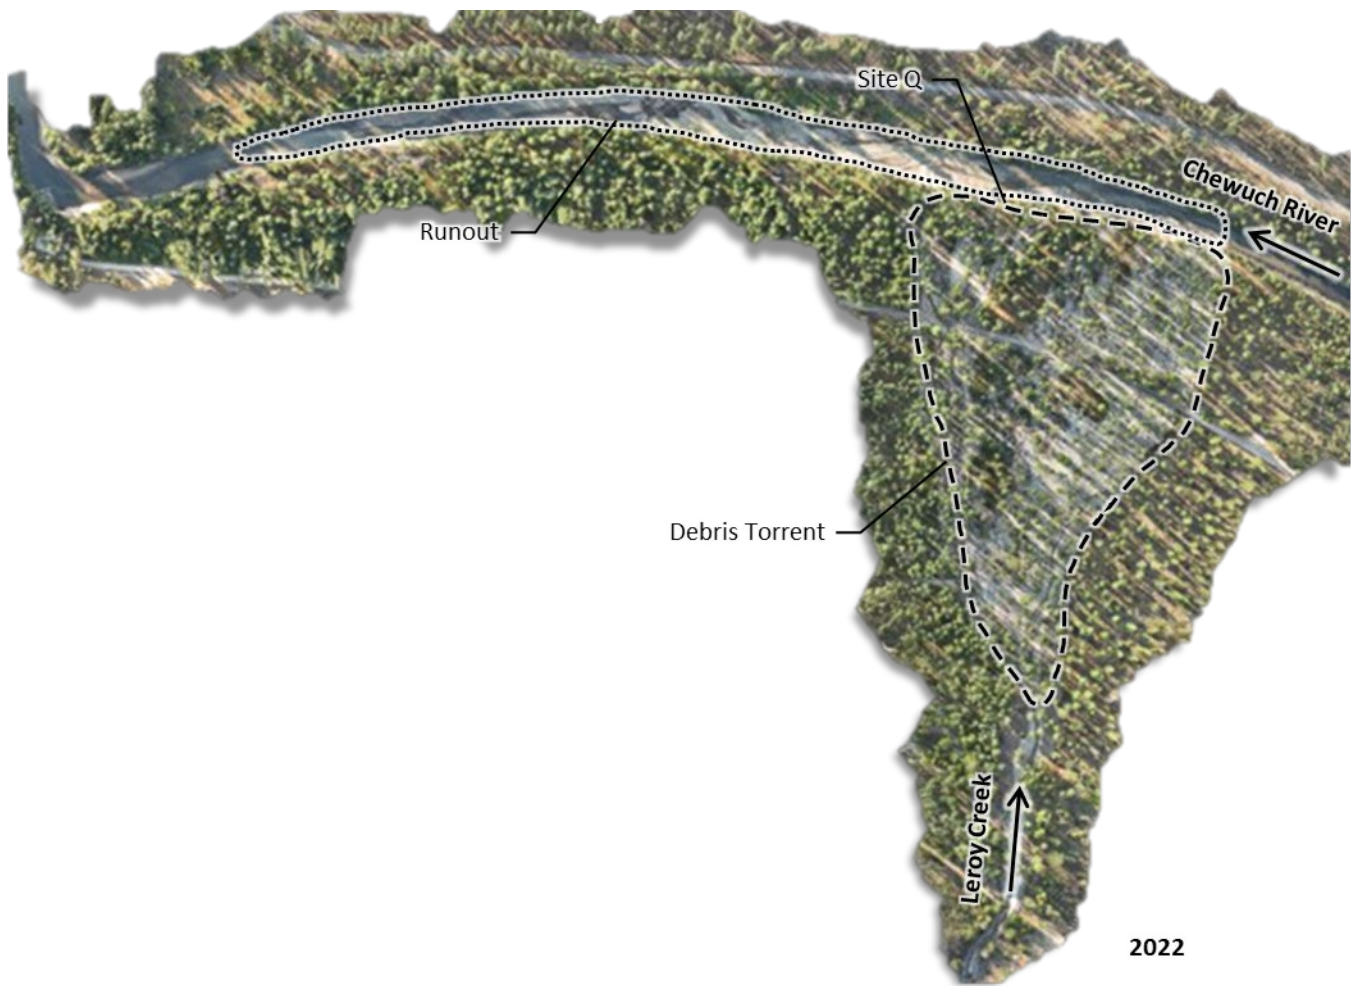
Figure 3-9. Drone photo of Leroy Creek debris flow.

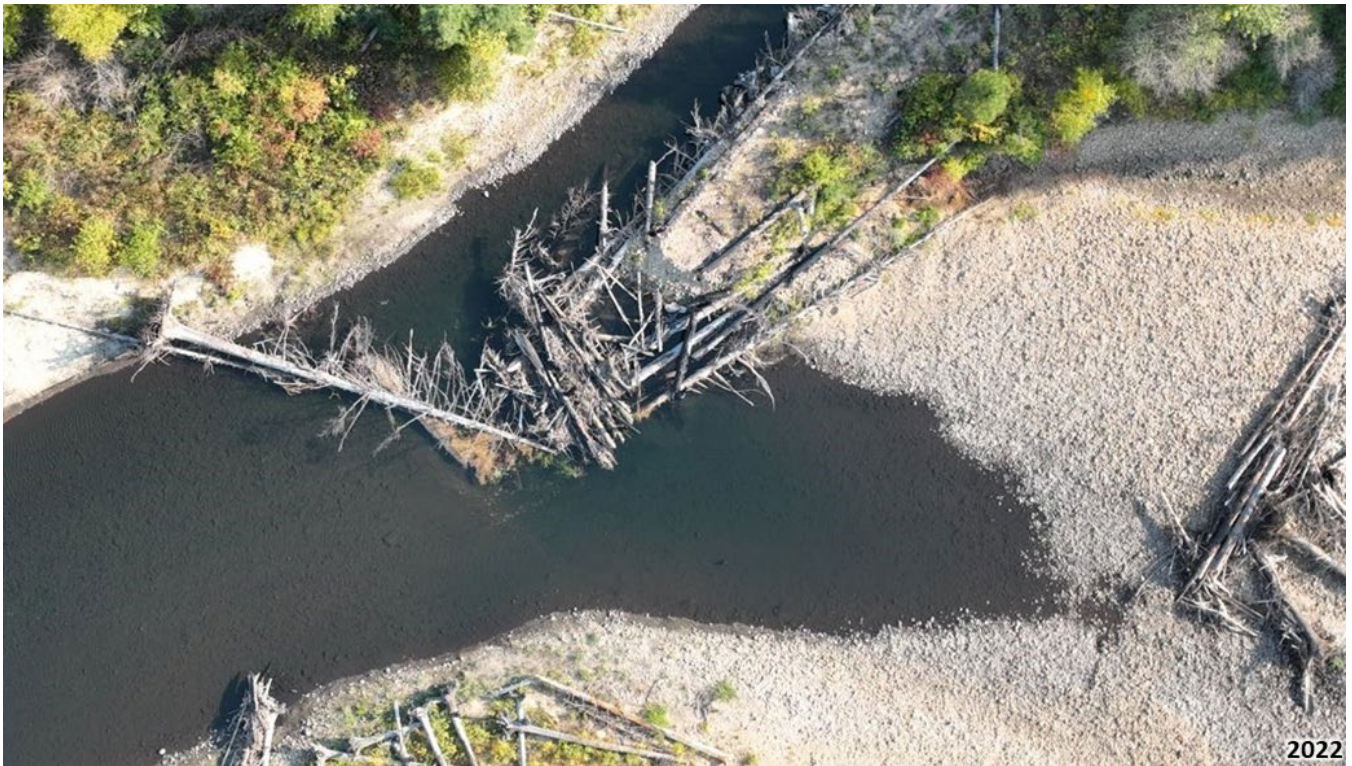
Site B was constructed in 2017. The project is an apex wood structure that was designed to create the geomorphic and hydraulic conditions necessary to maintain a side channel inlet to an old wetland channel complex upstream of the Leroy Creek debris torrent fan. The upper elevation logs of the inlet apex structure burned while the base layer of the jam did not. However, fire consumed key structural pieces of the jam, which greatly reduced the structural strength and footprint required to maintain the original geomorphic and hydraulic design condition intent. In 2021 there was a concern that the log jam could be outflanked between the burned segment of the structure and the old bank line. The 2022 spring runoff eroded this area of concern and it is now behaving in a way consistent with future flanking along the former bank caused by the loss of wood mass and roughness. There is still buried wood in this segment of channel, but it is unlikely to prevent flanking over the long-term unless the structure becomes sealed with natural wood during subsequent high flows or wood is imported to replace that lost in the fire. Figure 3-10, Figure 3-11, and Figure 3-12 show Site B post-fire.

Figure 3-10. Overview of Site B after the Cub Creek 2 Fire. Flow is left to right.

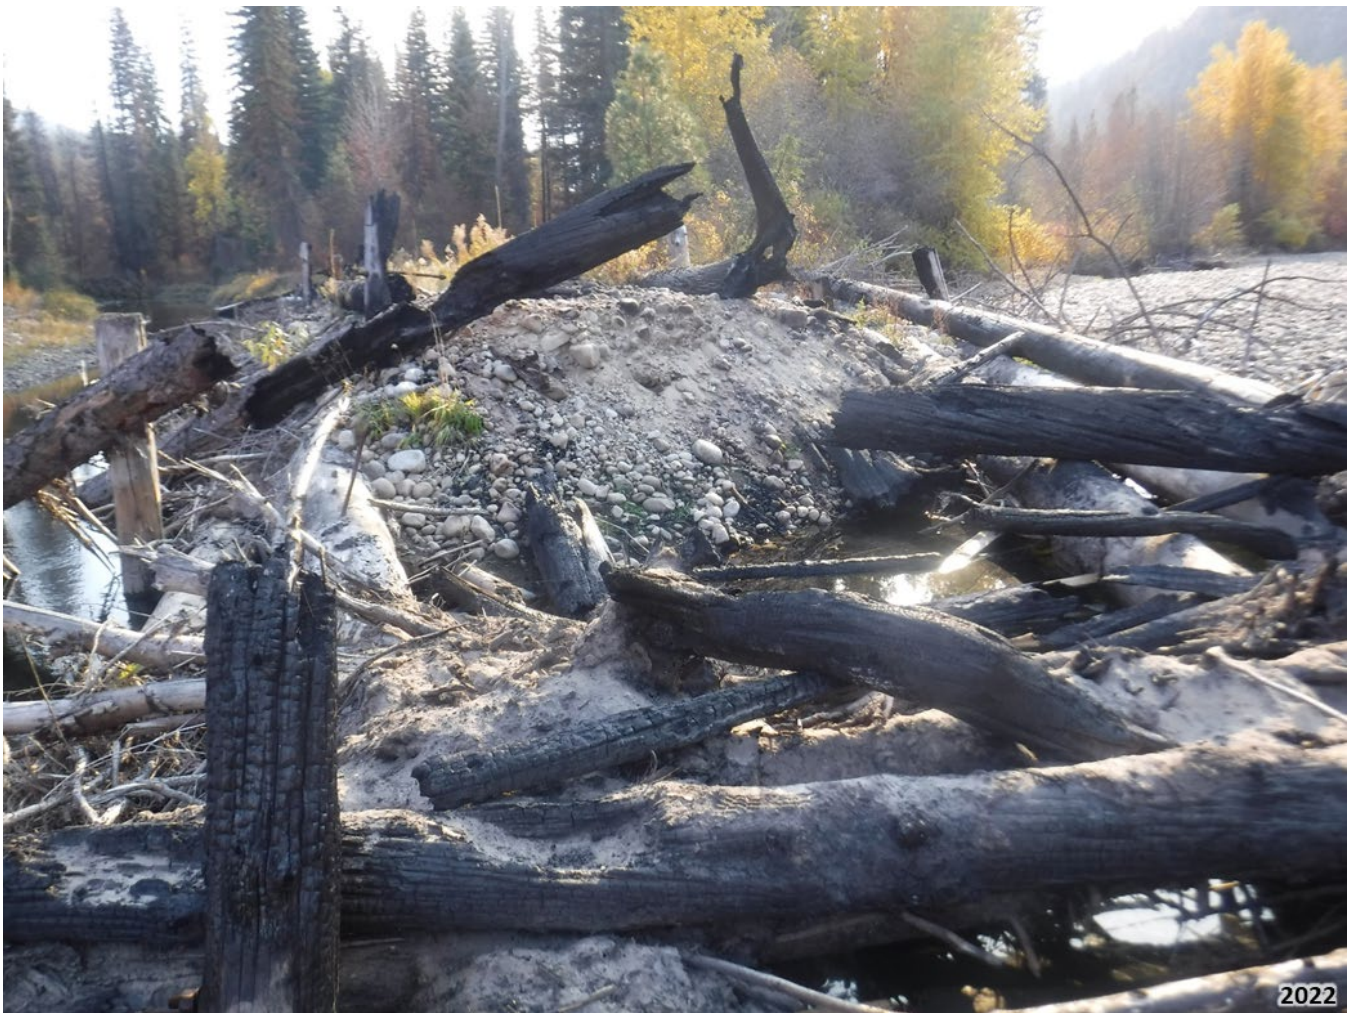
Figure 3-12. Photo of Site B post-fire looking downstream.

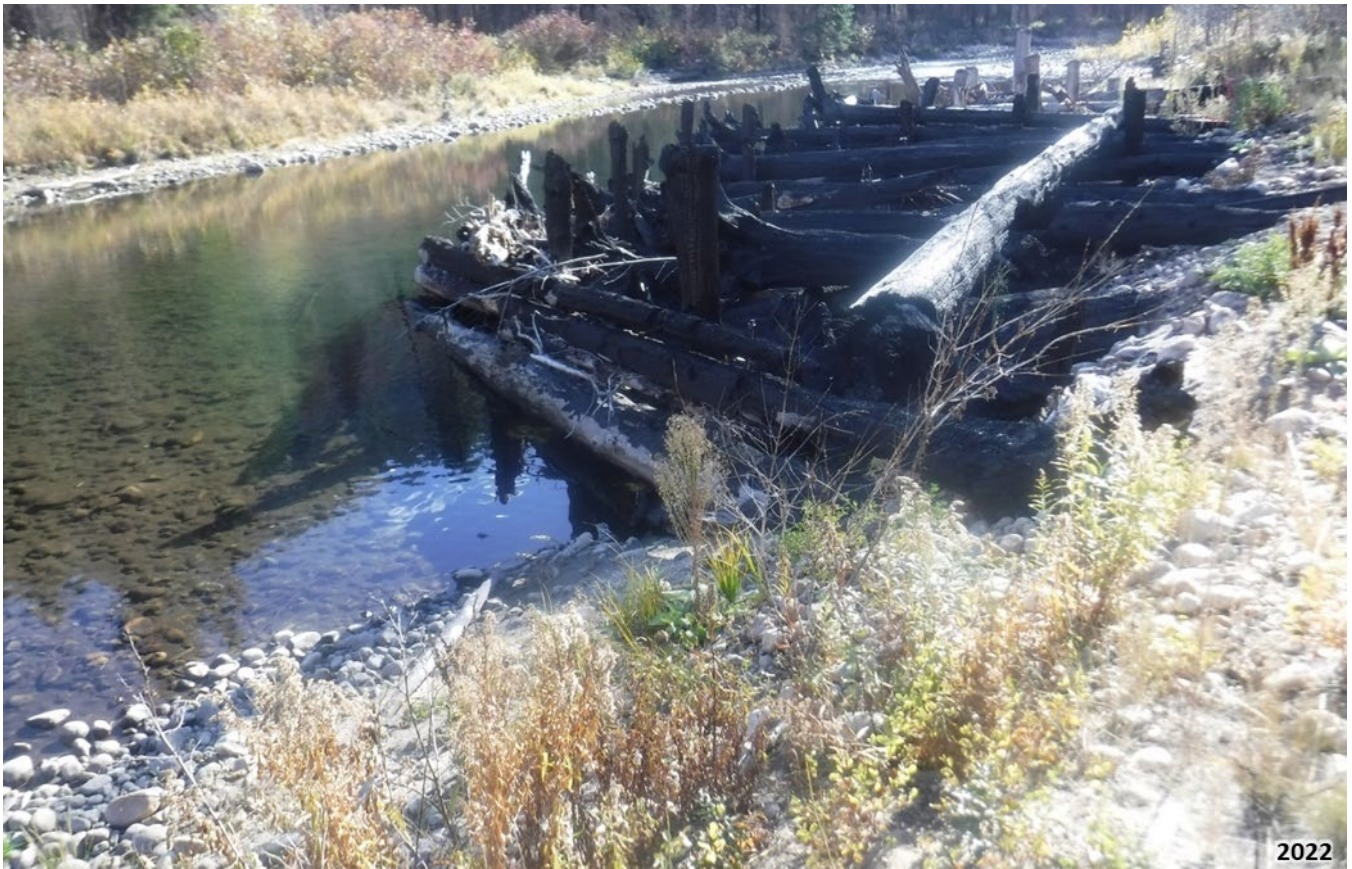
Site E is a right-bank and pile-ballasted large wood structure extending approximately 20 feet into the channel. It was constructed in 2017 and, until the fire, had not changed significantly since construction. Even after the fire, pool and cover habitat remain. However, the upstream 60% of the structure has been weakened from the fire. Logs and piles have smaller diameters and over time will fail to provide structural support during flood flows. Approximately 30% of the log jam structure is in good condition (Figure 3-13 and Figure 3-14). It is likely that some of the wood in the structure will leave the site and it is possible the front half of the structure will fail over time and collapse or accordion into the back half of the structure that remains unburned and relatively more stable.

Figure 3-13. Photo of Site E post-fire. Photo was taken looking downstream.

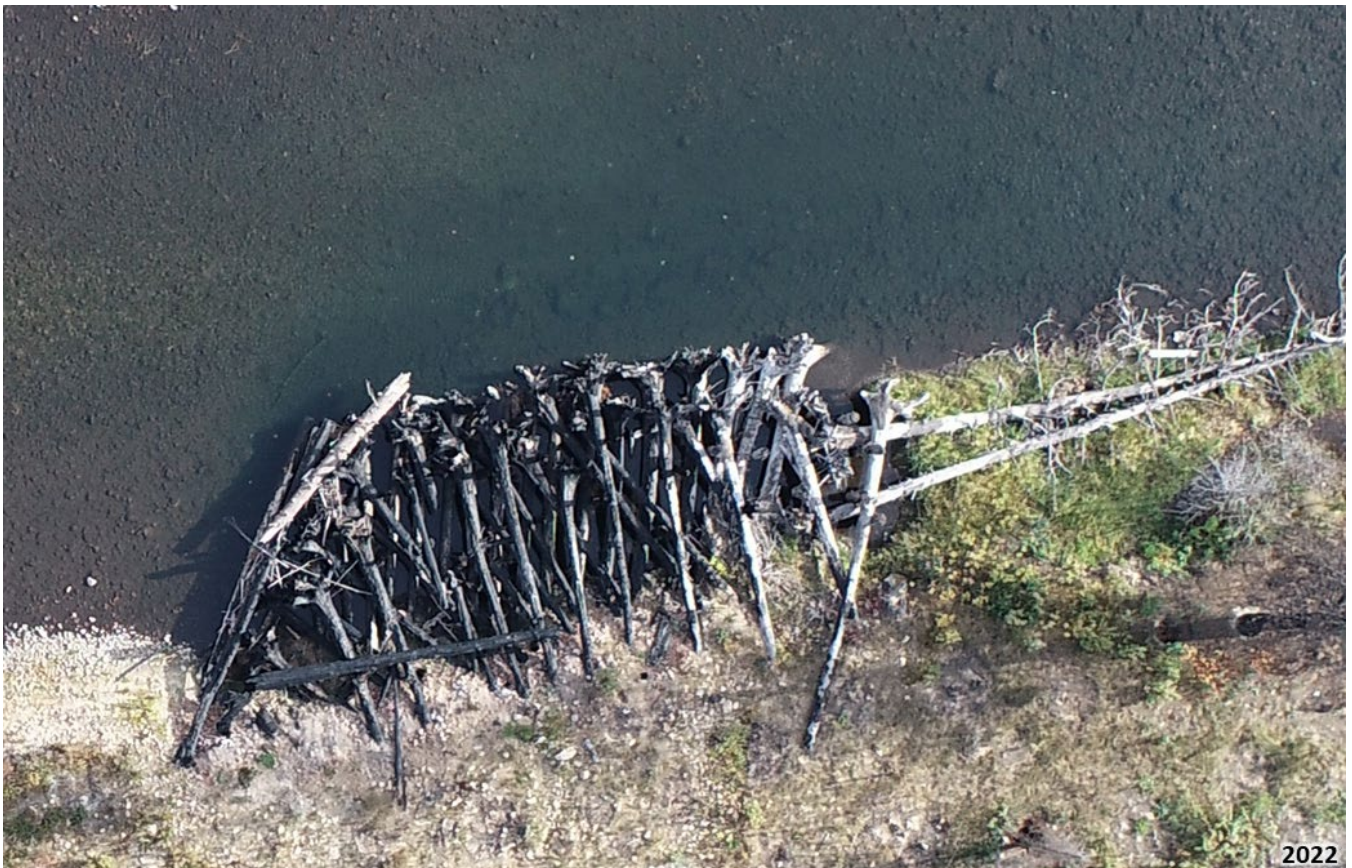
Figure 3-14. Overview of Site E post-fire. Flow is left to right.

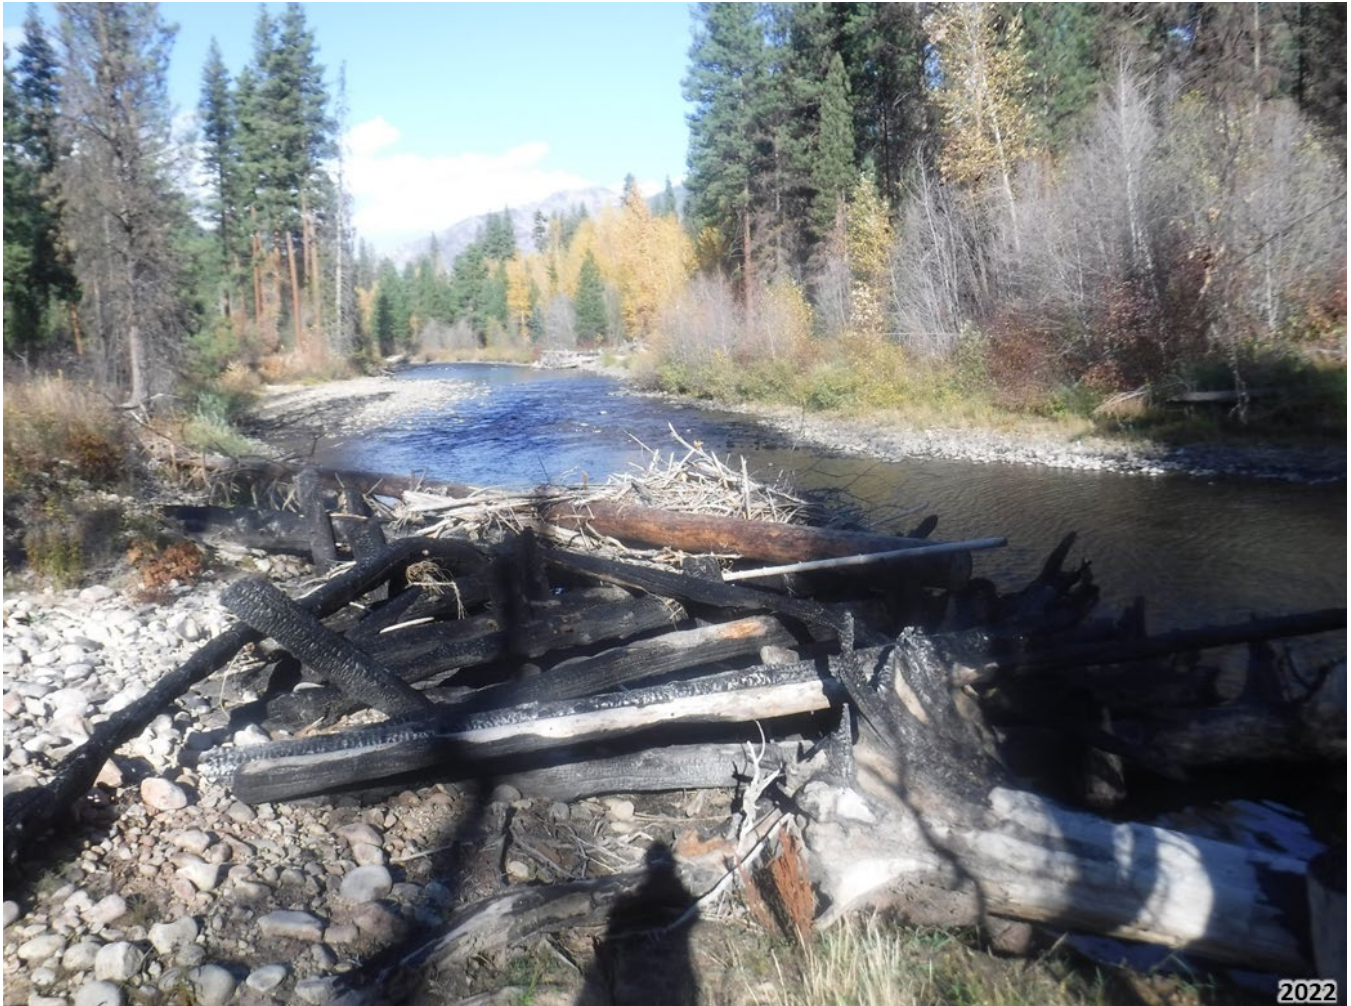
Site J is a right-bank and pile-ballasted large wood structure extending approximately 15 feet into the channel. It was constructed in 2017 and incorporated a large spruce tree as part of the structure (Figure 3-16). There is still good habitat at this project site. However, many of the key pieces have burned down to 12-inches in diameter. Bank-buried pieces have burned to 12 inches in diameter or have been completely severed from buried segments of the wood used to ballast the jam in place. The structure no longer has the original design strength and it is possible a portion of this jam will mobilize during future flood flows. Most of the piles are sound but what remains have smaller diameters and are weaker than installed diameters. Post-fire conditions of Site J are shown in Figure 3-15 and Figure 3-16.

Figure 3-15. Photo of site J post-fire. Photo taken looking upstream.

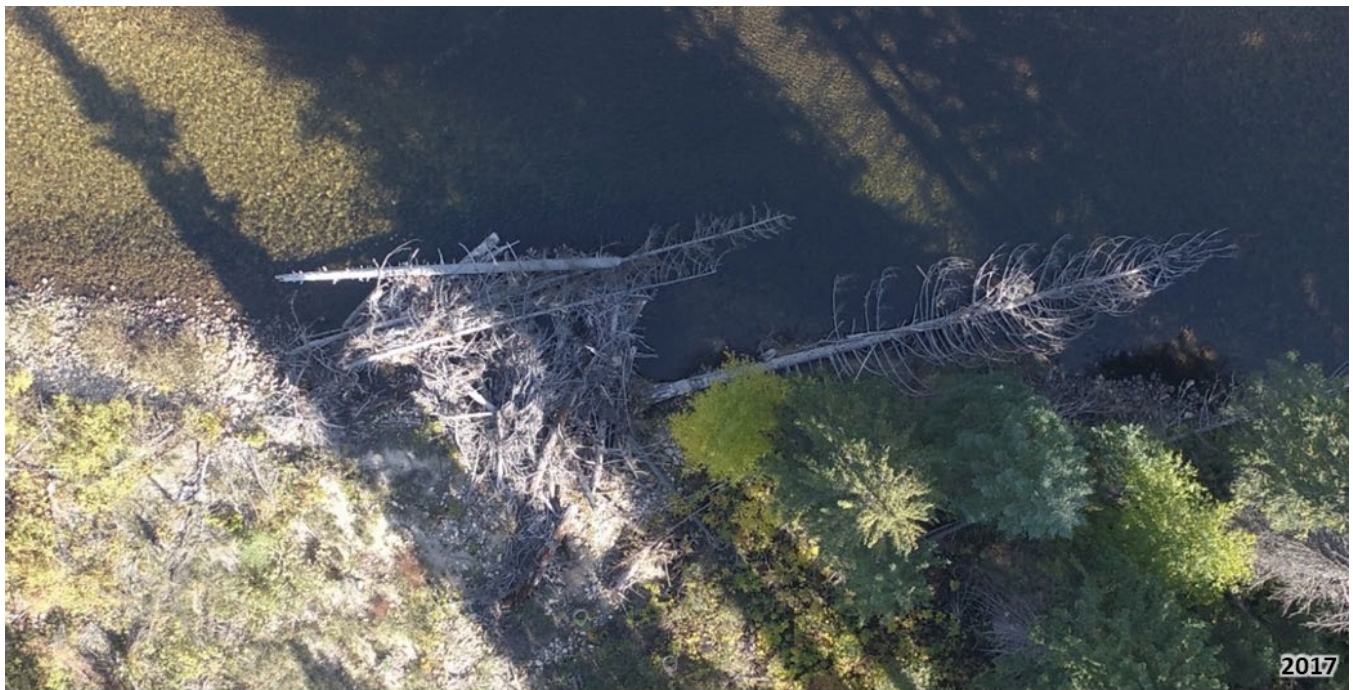
Figure 3-16. Overview of Site J pre-fire (top) and post-fire (bottom). Flow is left to right.

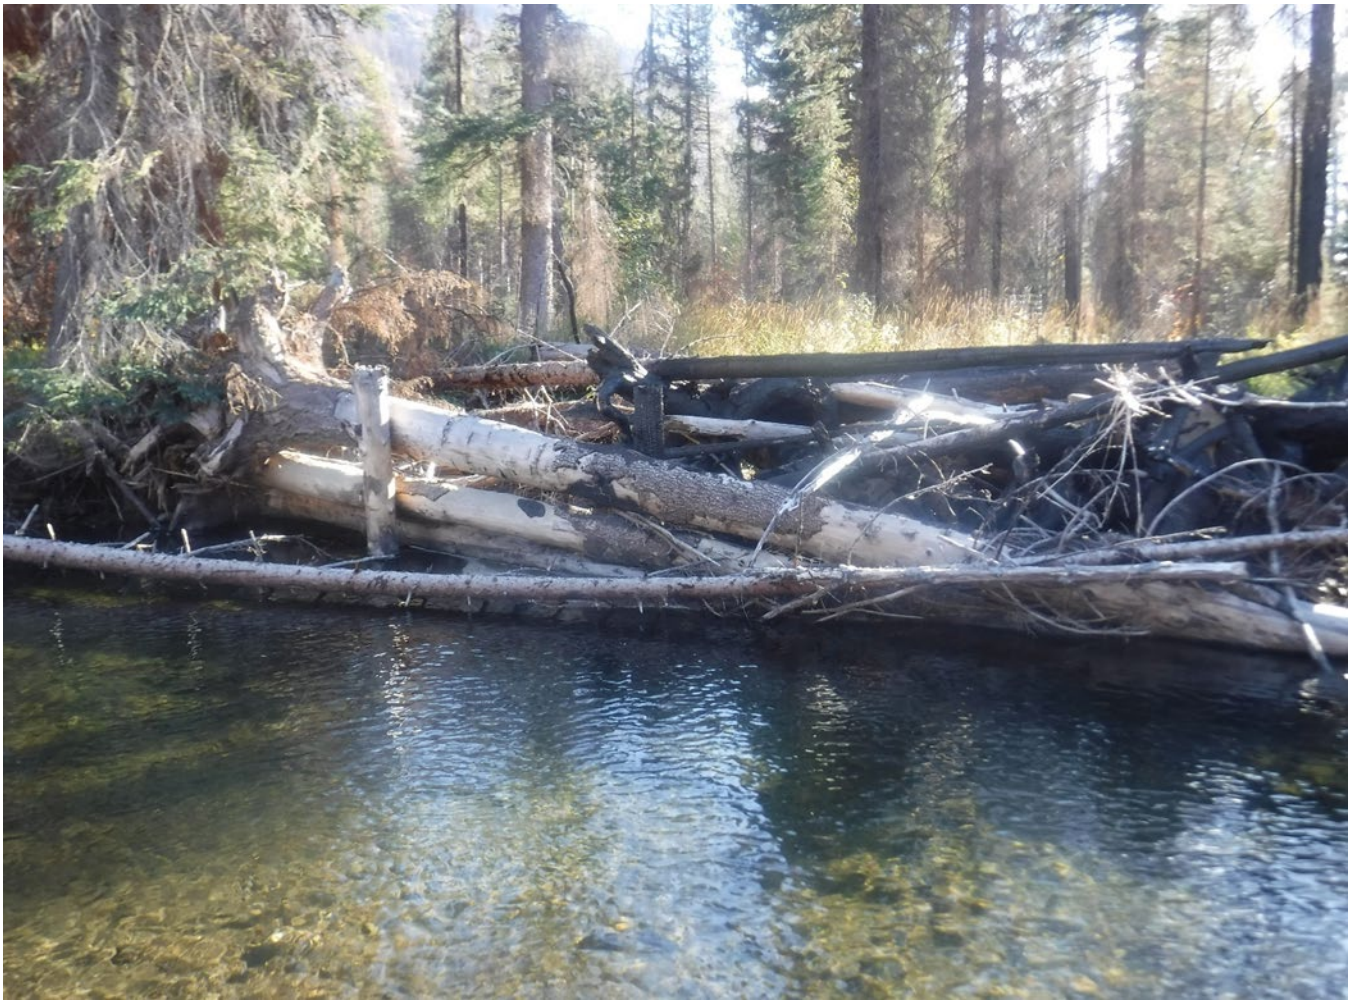
Site L is a left-bank and pile-ballasted large wood structure extending approximately 15 feet into the channel. It was constructed in 2018 and there is still post-fire habitat at this project site. All of the slash (small wood material < 2" in diameter) components of the log jam structure were consumed in the fire and a significant amount of burn through occurred on structural key pieces (Figure 3-17). While the supporting piles that burned are still useful, they do not provide the structural support of the original designs and it is possible some of the imported and burned wood could leave the site during high flows. Revegetation plantings throughout the access trail also burned.

Figure 3-17. Site L post-fire. Flow is left to right.

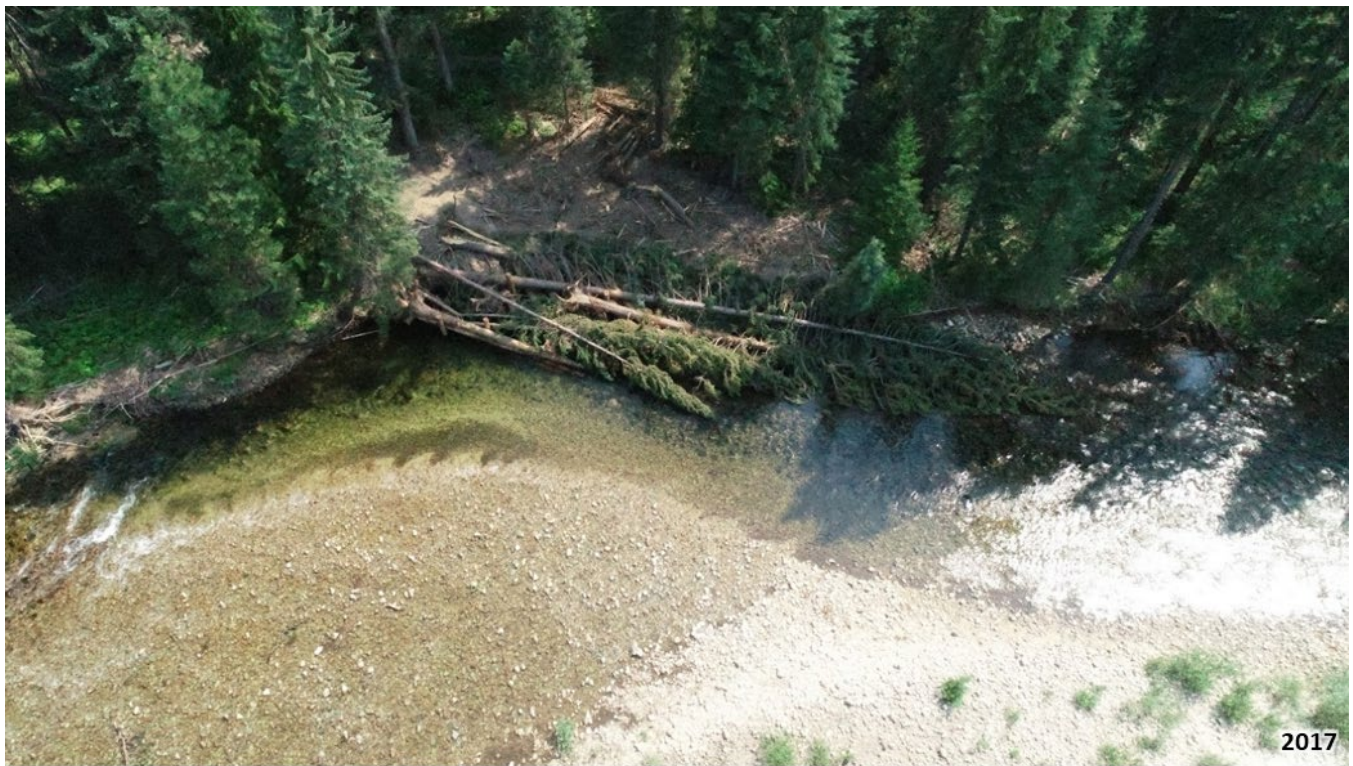
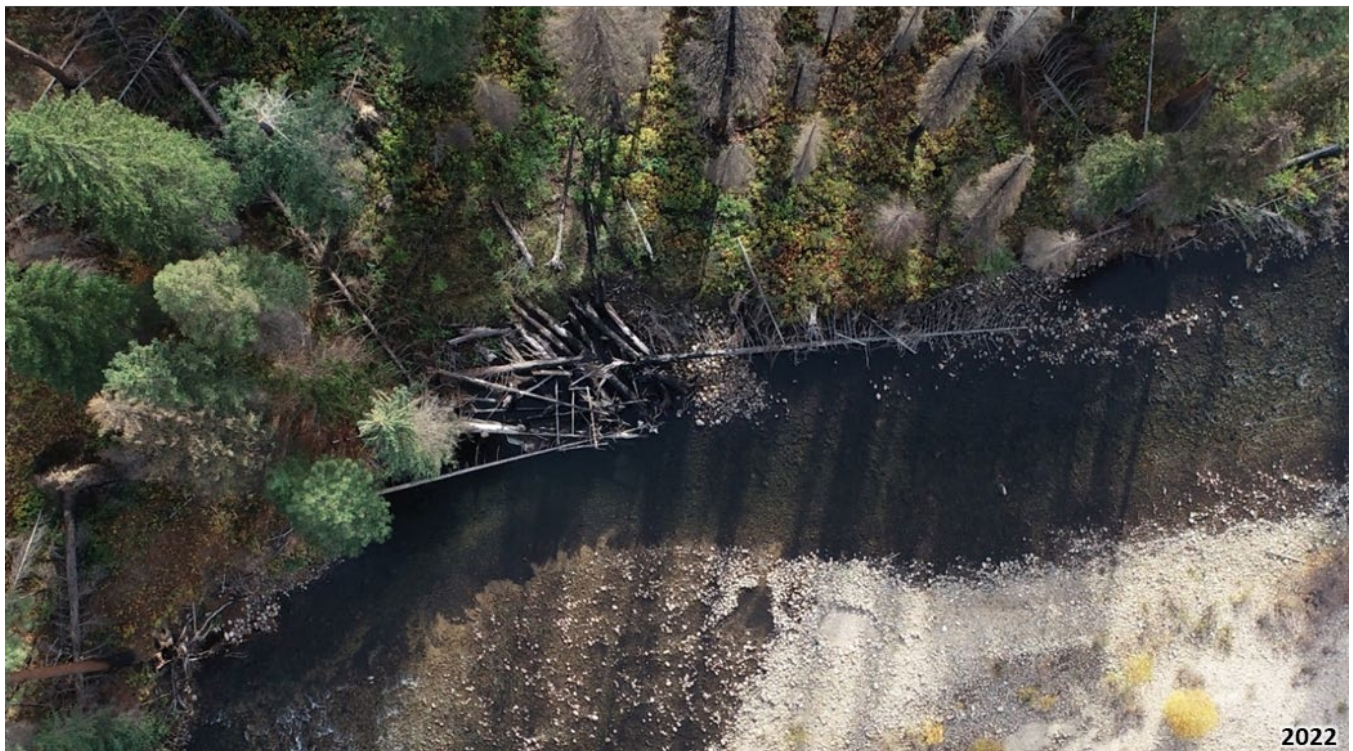
Figure 3-18. Site L pre-fire (top) and post-fire (bottom). Flow is left to right.

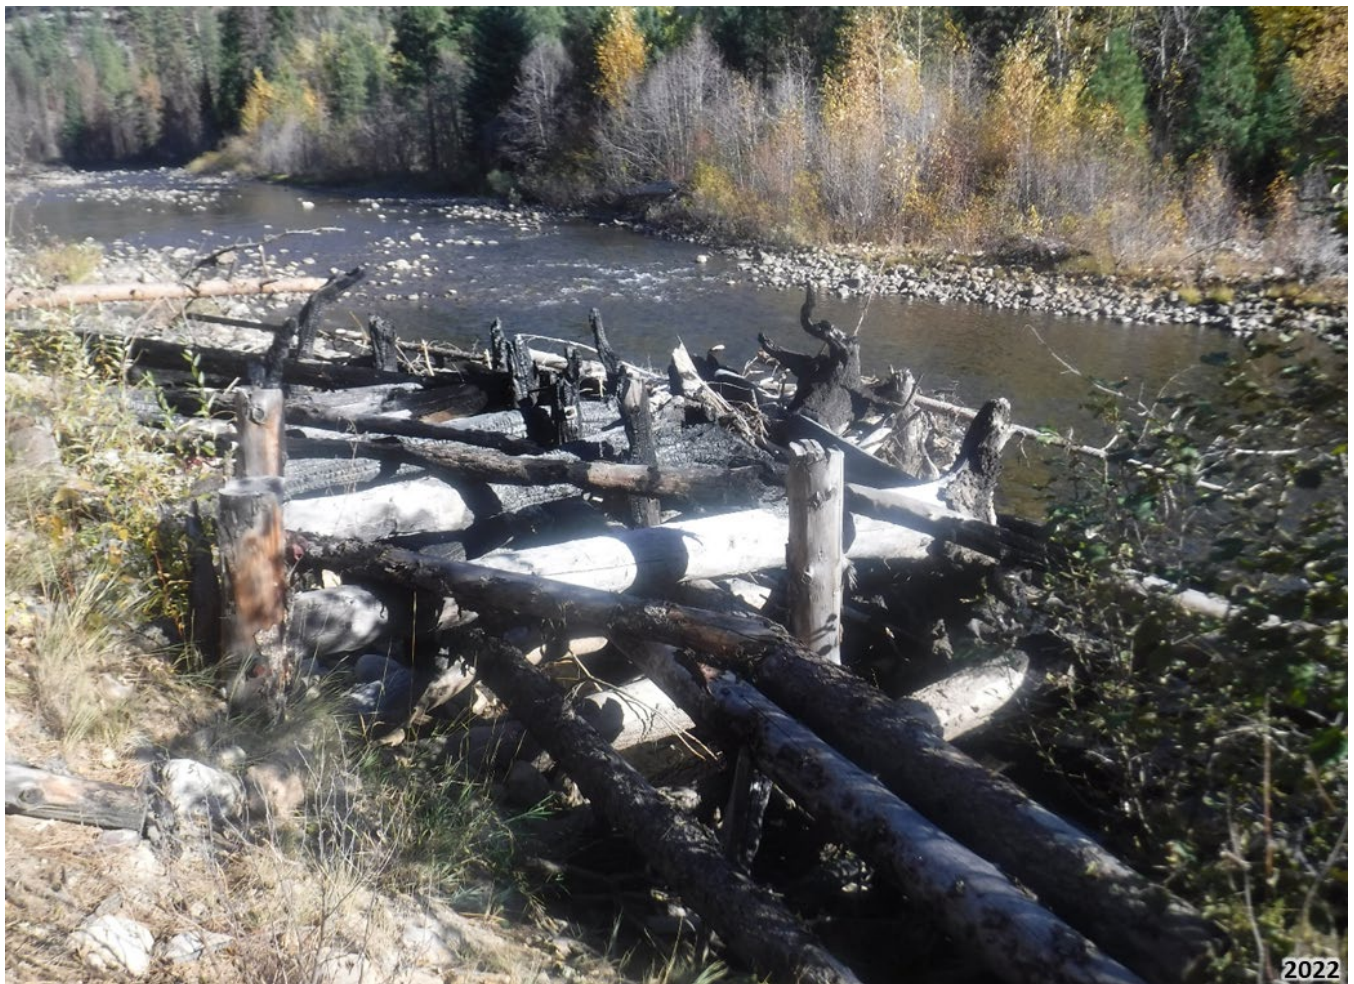
Site M is a right-bank and pile-ballasted wood structure that extended 15 feet into the channel. It was constructed in 2018. Most of the Site M log jam was consumed by the Cub Creek 2 Fire (Figure 3-19 and Figure 3-20). Structural integrity has been significantly degraded and it is likely future flood flows will remove much of what is left of the jam over time. It is possible the lower or first layer of wood and remaining piles will collect wood that is transported from upstream sources and create wood habitat at the site.

Figure 3-19. Site M post-fire. Photo taken looking upstream.

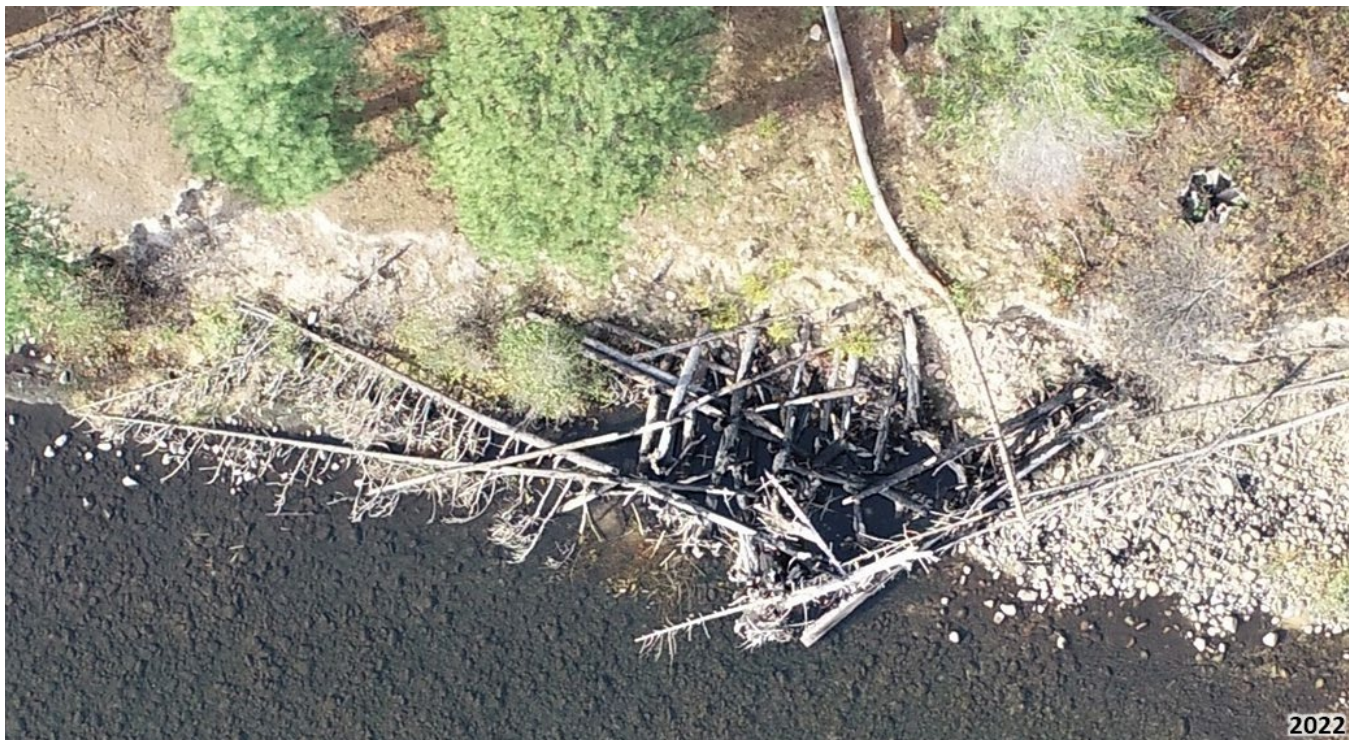
Figure 3-20. Site M post-fire. Flow is right to left.

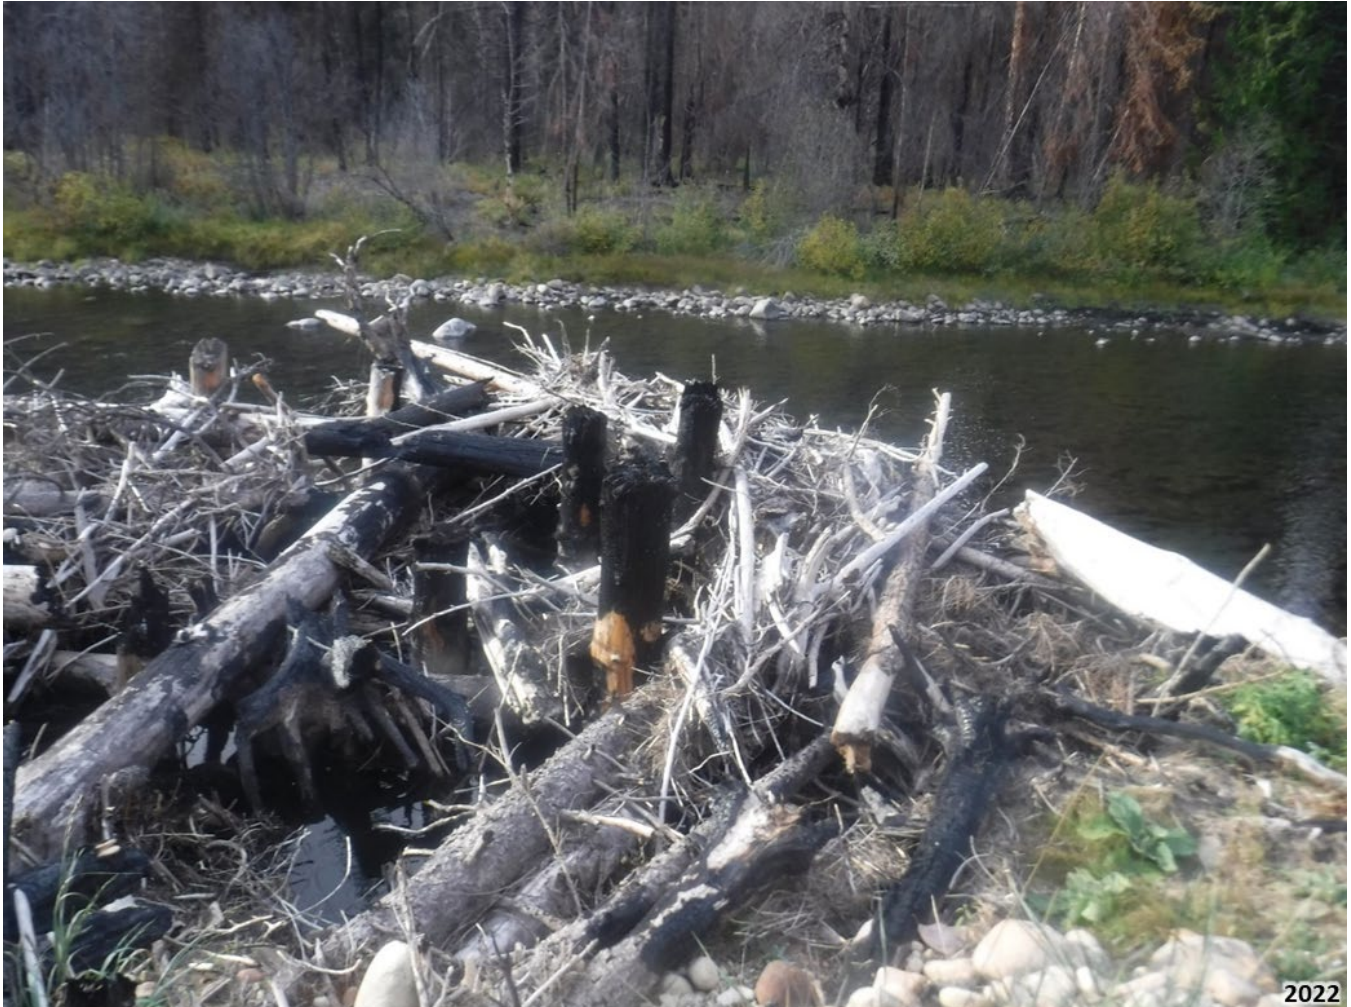
Site N is a left-bank and pile-ballasted wood structure extending 20 feet out into the channel. Cub Creek 2 Fire burned a significant volume of the Site N structure (Figure 3-21 and Figure 3-22). Design integrity has been lost and it is possible the top half of the structure will be removed by future flood flows. What remains of the piles is solid, but most threaded rod connections have been lost. The first layer of wood in the jam will likely remain, but without the top of the jam in place, the hydraulic forces necessary to maintain a scour pool will be less. It is possible the remaining piles of this structure will collect upstream-sourced wood and, if this occurs, it is possible a log jam will remain established at the site. If accumulations are large enough, a scour pool could be maintained. Natural vegetation is becoming re-established. Since the fire, a significant volume of slash has accumulated at the upstream face of the structure and remaining piles.

Figure 3-21. Site N post-fire. Flow is from right to left. Lighter-colored material on the upstream face of the jam is naturally rafted wood that accumulated post-fire.

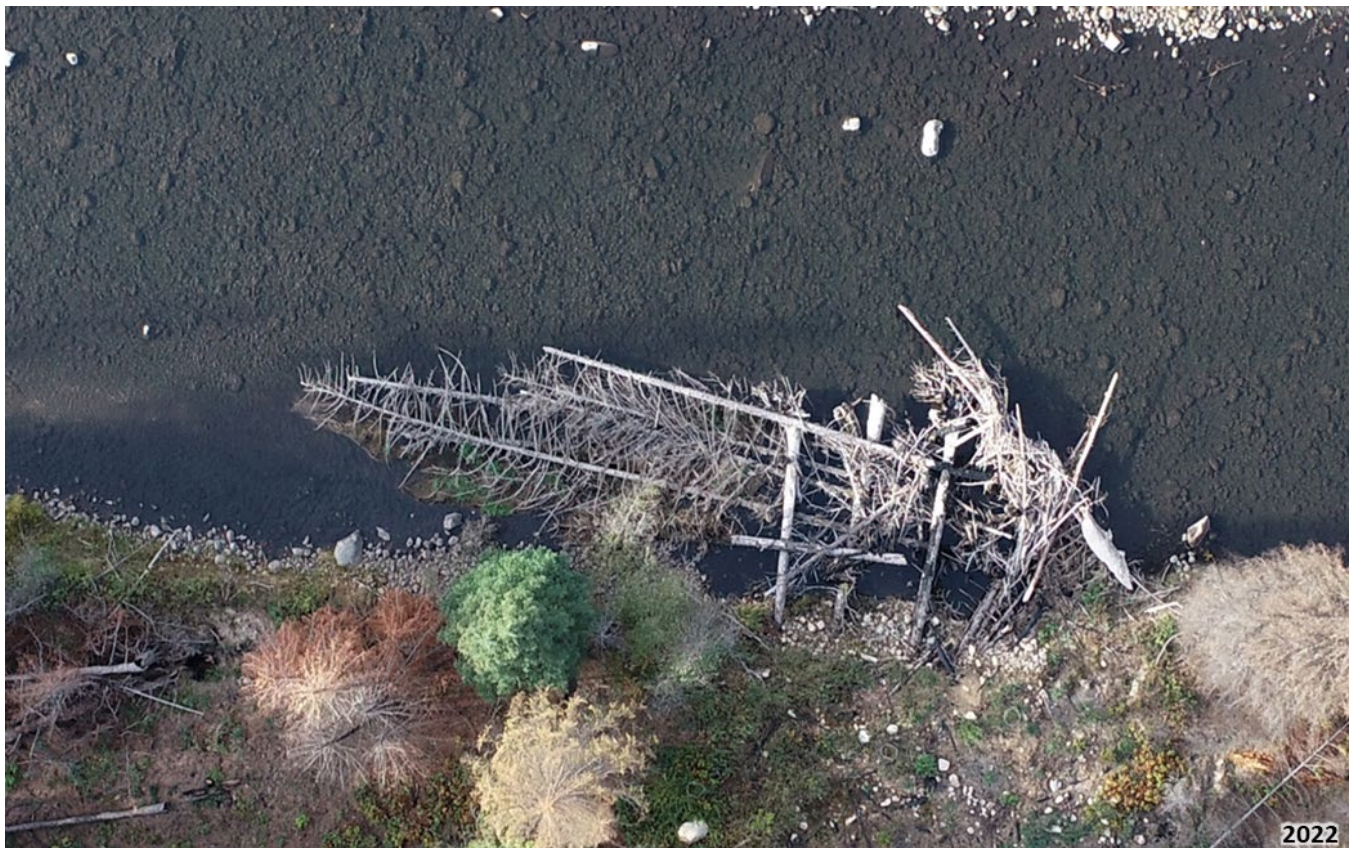
Figure 3-22. Site N post-fire. Flow is from right to left.

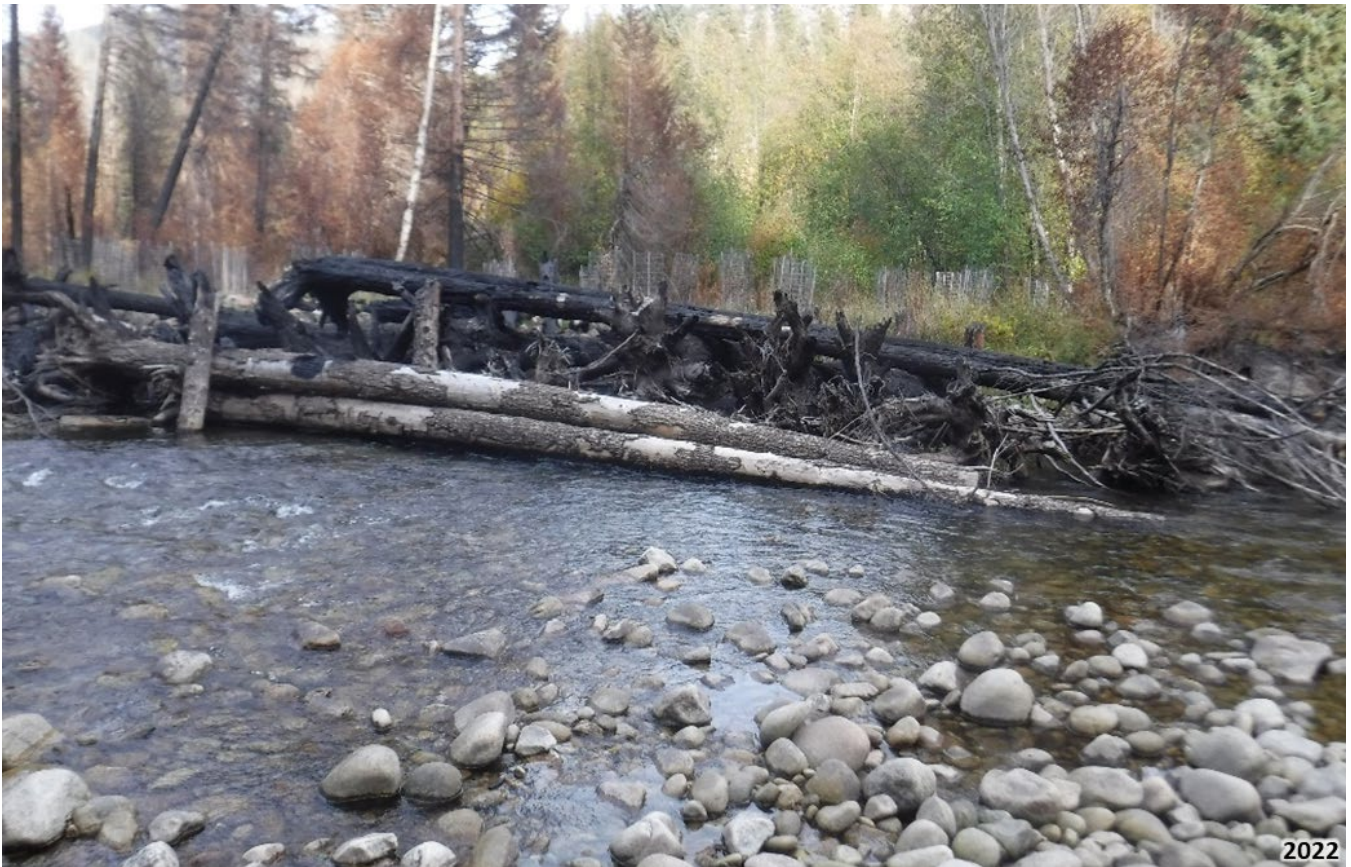
Site P is a left-bank and pile-ballasted wood structure extending 15 feet out into the channel. Although damaged, the structure continues to function and can be expected to maintain its original design stability and habitat utility. Much of its resiliency can be attributed to the larger size class diameter of the wood used in the original construction (Figure 3-23 and Figure 3-24). Imported large wood with root wads that were delivered to the project had a specified minimum diameter range between 18-inches and 24-inches. By chance, wood delivered to Site P was in the upper range of the size specification (24-inches in diameter) and in some cases approached 28-inches in diameter. Although the burn intensity at Site P was similar to the burn intensity at other sites, larger diameter logs used at Site P resulted in logs with larger post-burn diameters and therefore greater post-fire resiliency and stability.

Figure 3-23. Site P post-fire. Flow is from left to right.
