Wildfire and River Restoration: Case Studies from the Methow River Watershed

For U. S. Bureau of Reclamation
July 2023

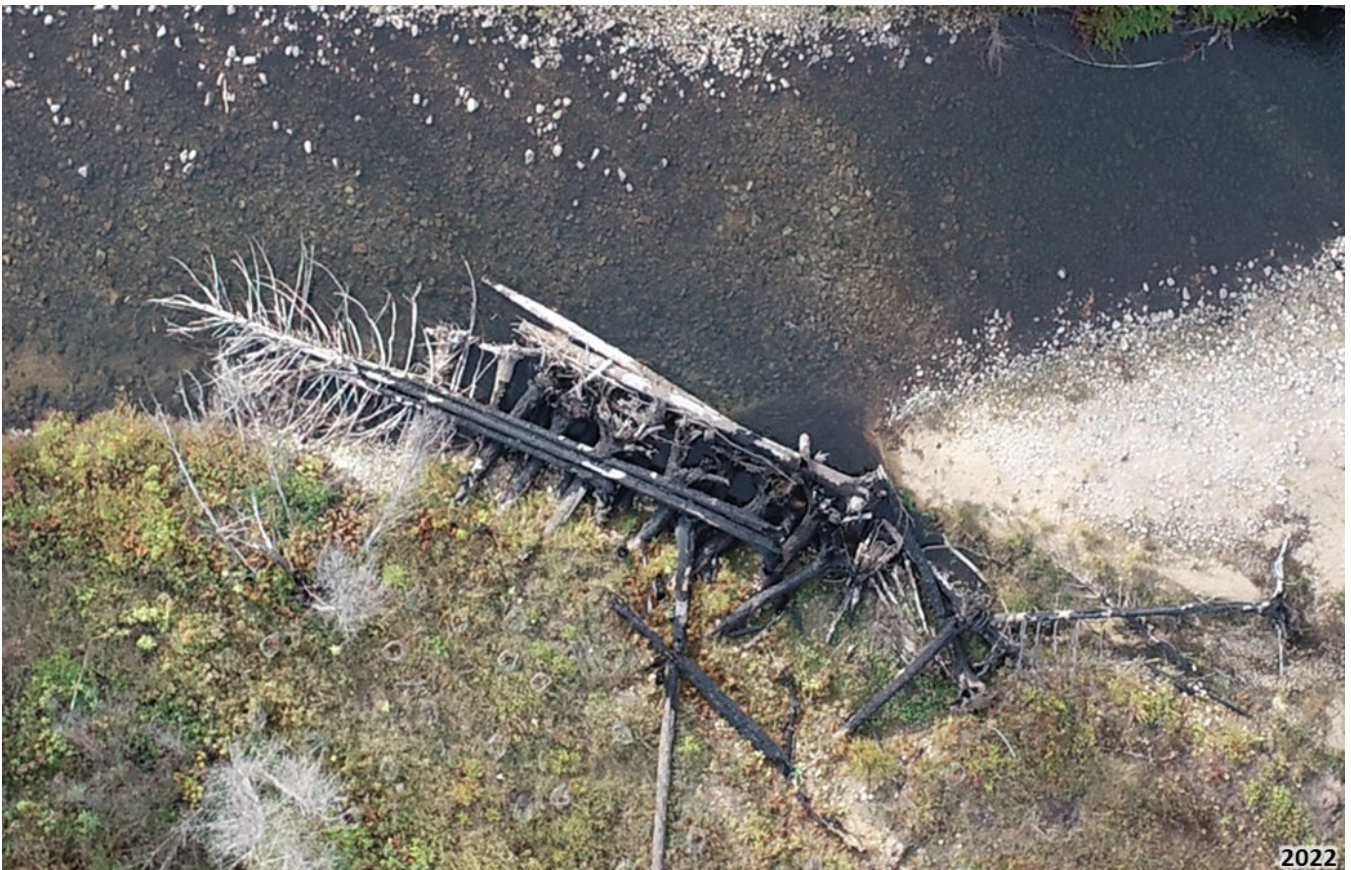
Figure 3-24. Site P post-fire. Flow is from right to left.

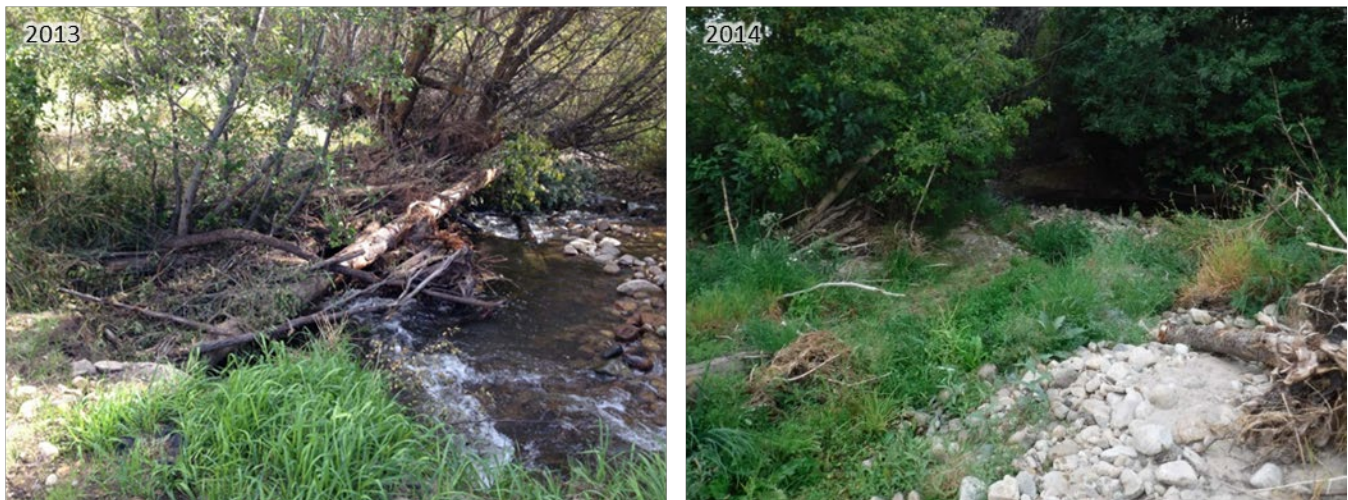
Site A was designed to provide cover habitat and enhance an existing pool bedform. Figure 3-31 and Figure 3-32 show the immediate impacts from the debris flows associated with the 5-year flow event that occurred on August 13, 2014. The adjacent riparian area and wood structure were not burned during the fire. However, the elevated sediment load during the 2014 post-fire debris torrent event buried the old channel alignment, former pool habitat, and wood structure. A new avulsion channel was established during the event when cobble and gravel substrate deposited upstream of Site A and the channel migrated laterally through adjacent fully burned riparian area. Site A is located in a relatively wider valley bottom segment of Beaver Creek and naturally more susceptible to a loss in sediment transport, lateral migration, and avulsion response to high bedload transport events. The source material that buried Site A appeared to have been from the upstream riparian bank failure caused by debris jam development and channel migration into fire burned and weakened banks.

Figure 3-31. Site A looking downstream. Left: immediately post-construction (2013). Right: post-fire, post-5-year flow event (2014).

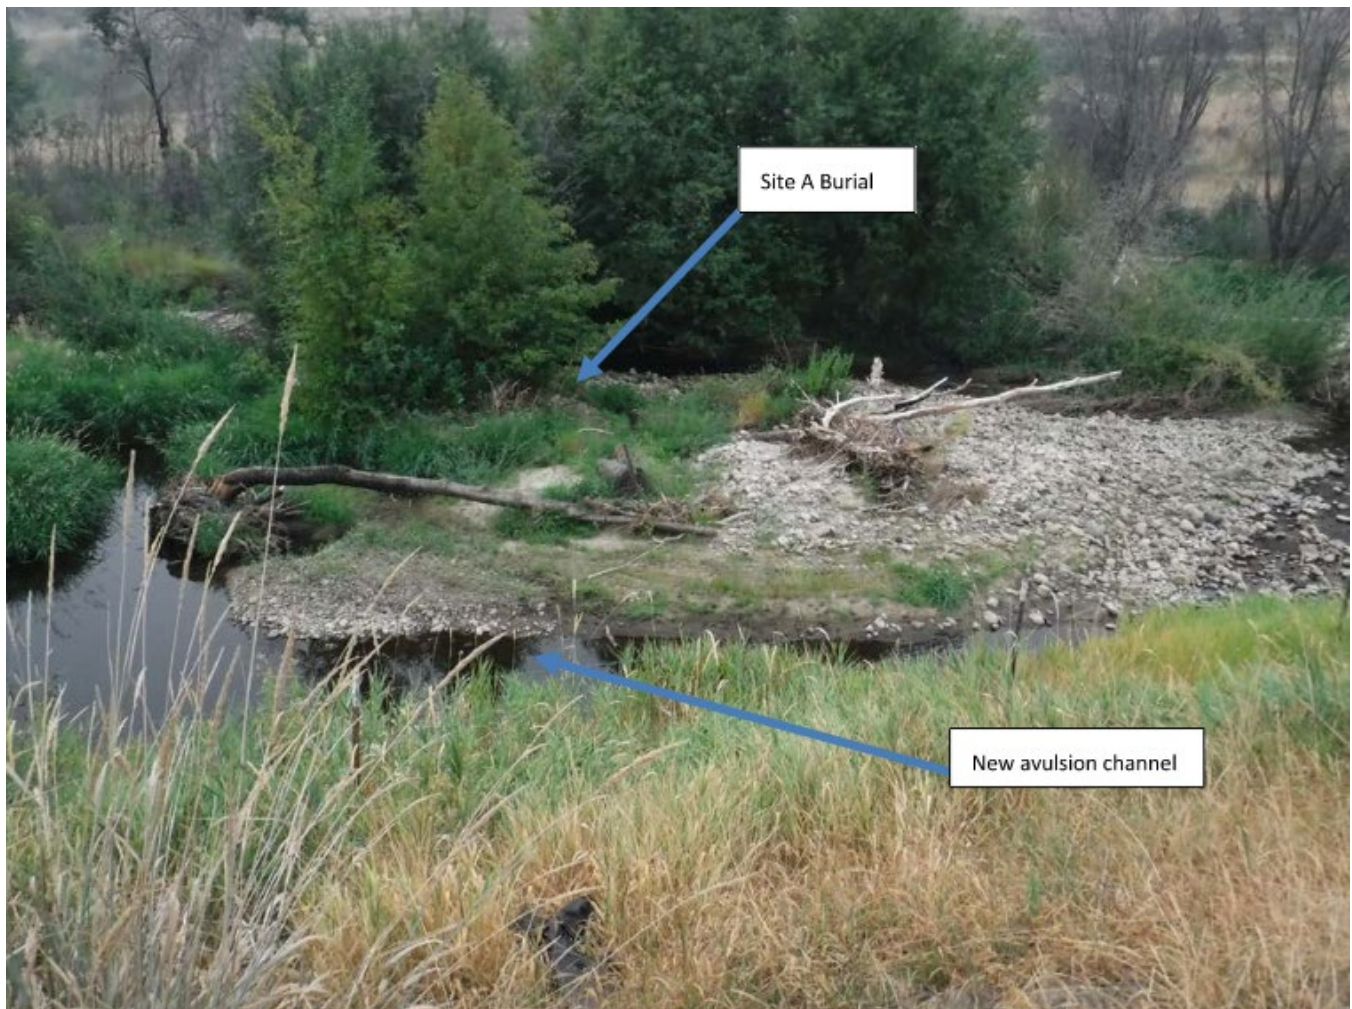
Figure 3-32. Site A showing new avulsion channel following fire and 5-year flow event (2014).

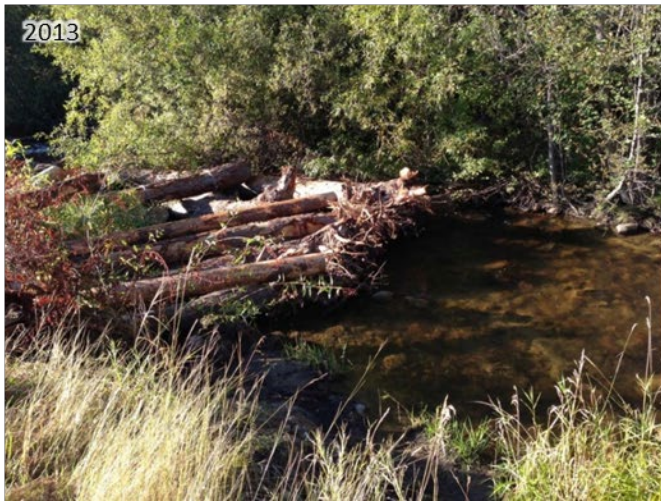
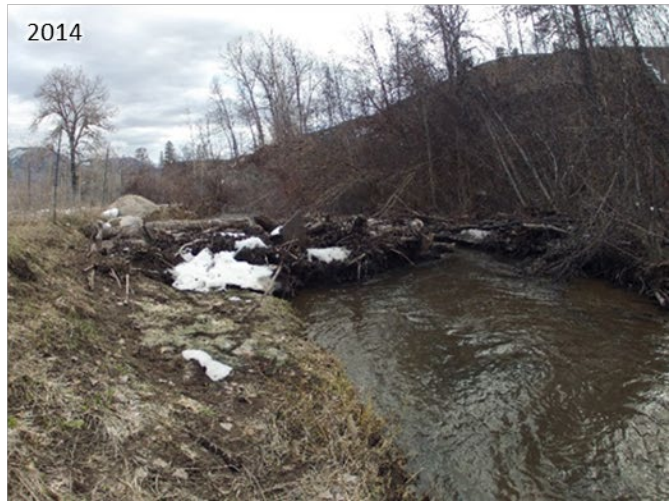
Site B was constructed to create habitat at the bottom of a steeper, more entrenched boulder bed channel segment at the beginning of a flatter, wider valley segment. The intent of the log jam was to force lateral migration and enhance gravel deposition, pool formation, and rearing habitat at all flows. To meet those objectives, the structure occluded approximately 80 percent of the channel capacity. Although the wood structure was not burned, adjacent native and post-project riparian plantings were completely consumed by the fire. Post-fire flooding caused the right bank lateral migration as intended and the structure collected a significant volume of burned slash and spawning-sized gravel downstream of the site. Figure 3-33 shows the changes to Site B after the fire and estimated 5-year flow event of 2014. The constructed log jam racked slash-size material and has caused bank erosion and channel migration to the right.

Figure 3-33. Site B looking downstream. Left: immediately post-construction (2013). Right: post-fire, post-5-year flow event (2014).

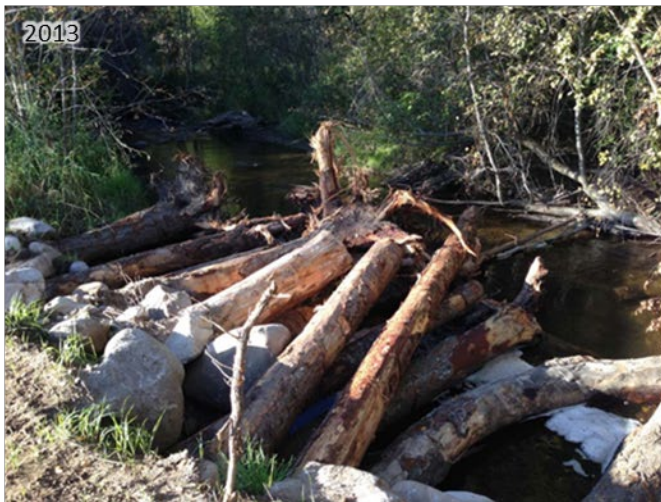
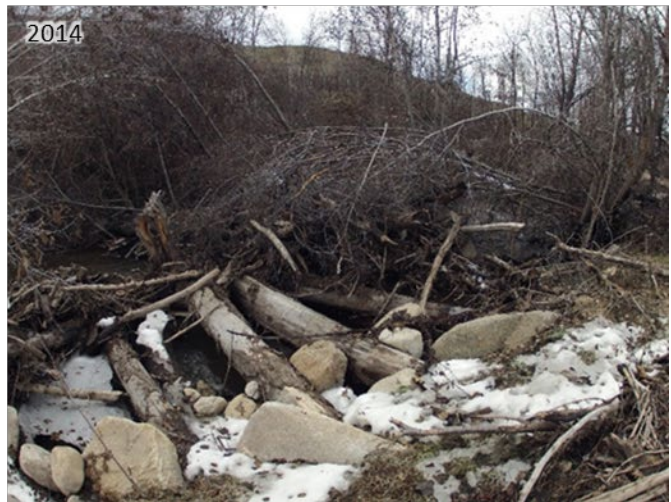
Site C was constructed to enhance a natural slope break and pool bedform in a relatively wider flood-prone segment of the valley downstream of a steeper channel segment composed of cobble, gravel, and boulder lag deposits. The structure was intended to improve complexity and rearing habitat during low and high flows. The riparian area and post-fire plantings were burned but the structure was largely unburned by the fire. Flood flows and sediment loads did not significantly impact the project site and habitat.

Figure 3-34. Site C looking downstream. Left: immediately post-construction (2013). Right: post-fire, post-5-year flow event (2014).

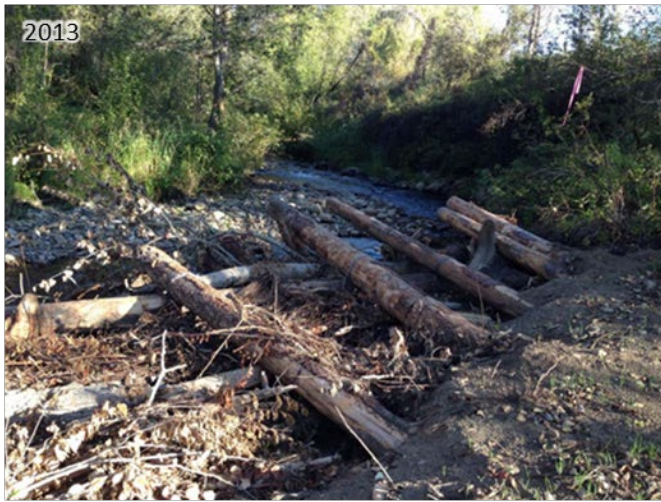
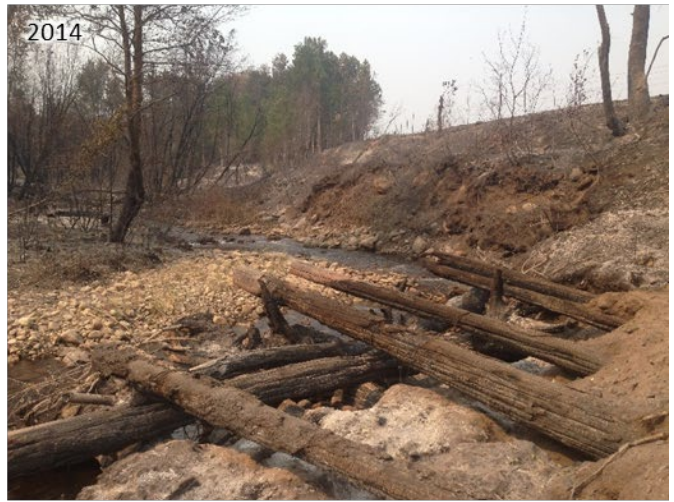
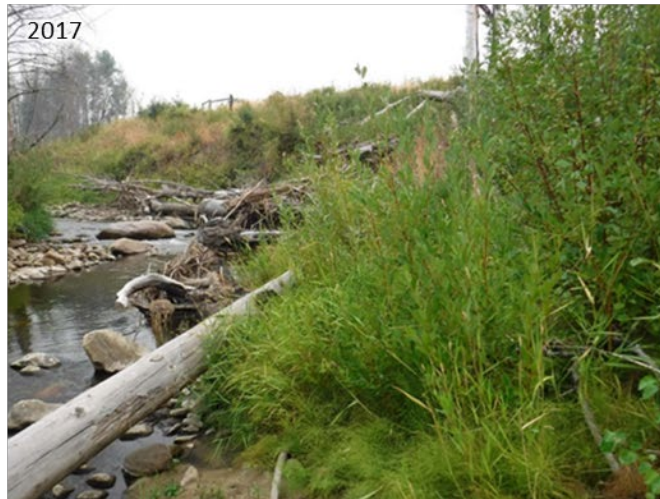
Figure 3-35. Site D looking upstream. Upper left: immediately post-construction (2013). Upper right: post-fire, post-5-year flow event (2014). Bottom: post-7.5-year flow event (2017).

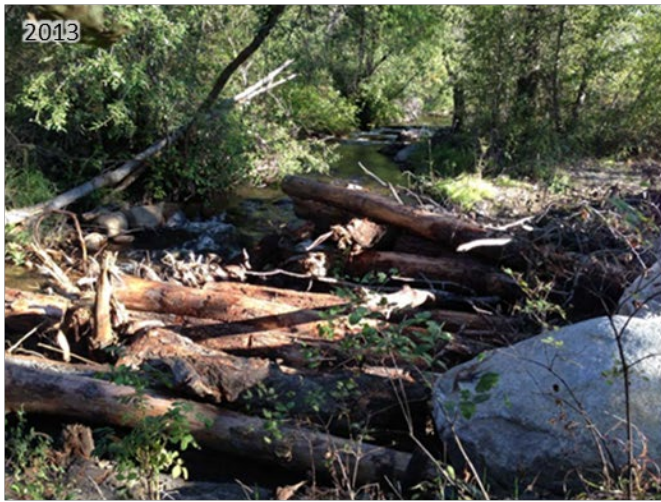
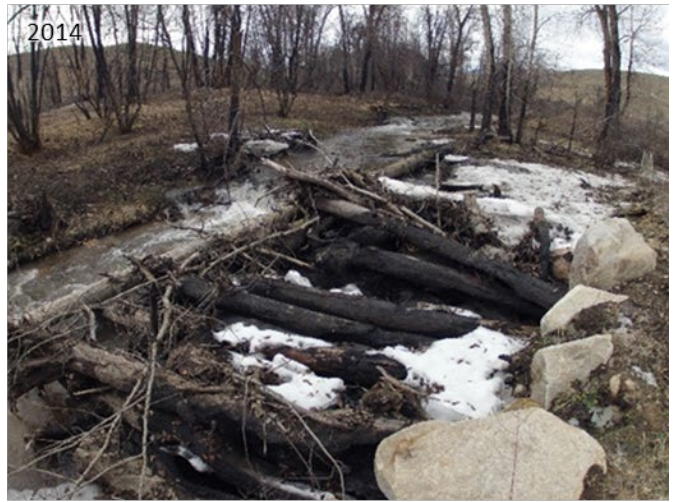
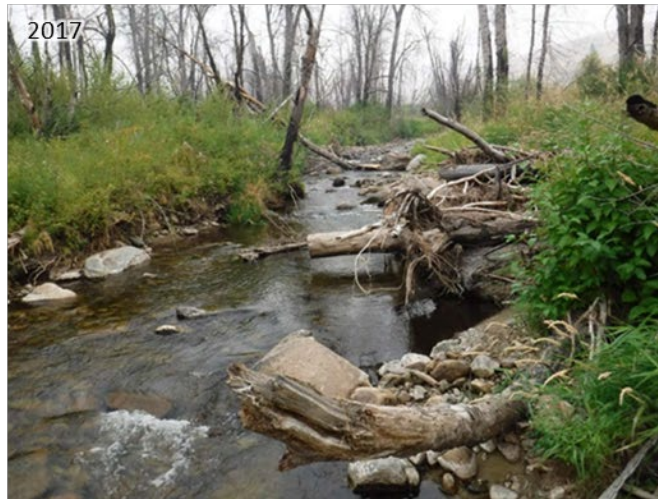
Figure 3-36. Site E looking upstream. Upper left: immediately post-construction (2013). Upper right: post-fire, post-5-year flow event (2014). Bottom: post-7.5-year flow event (2017).

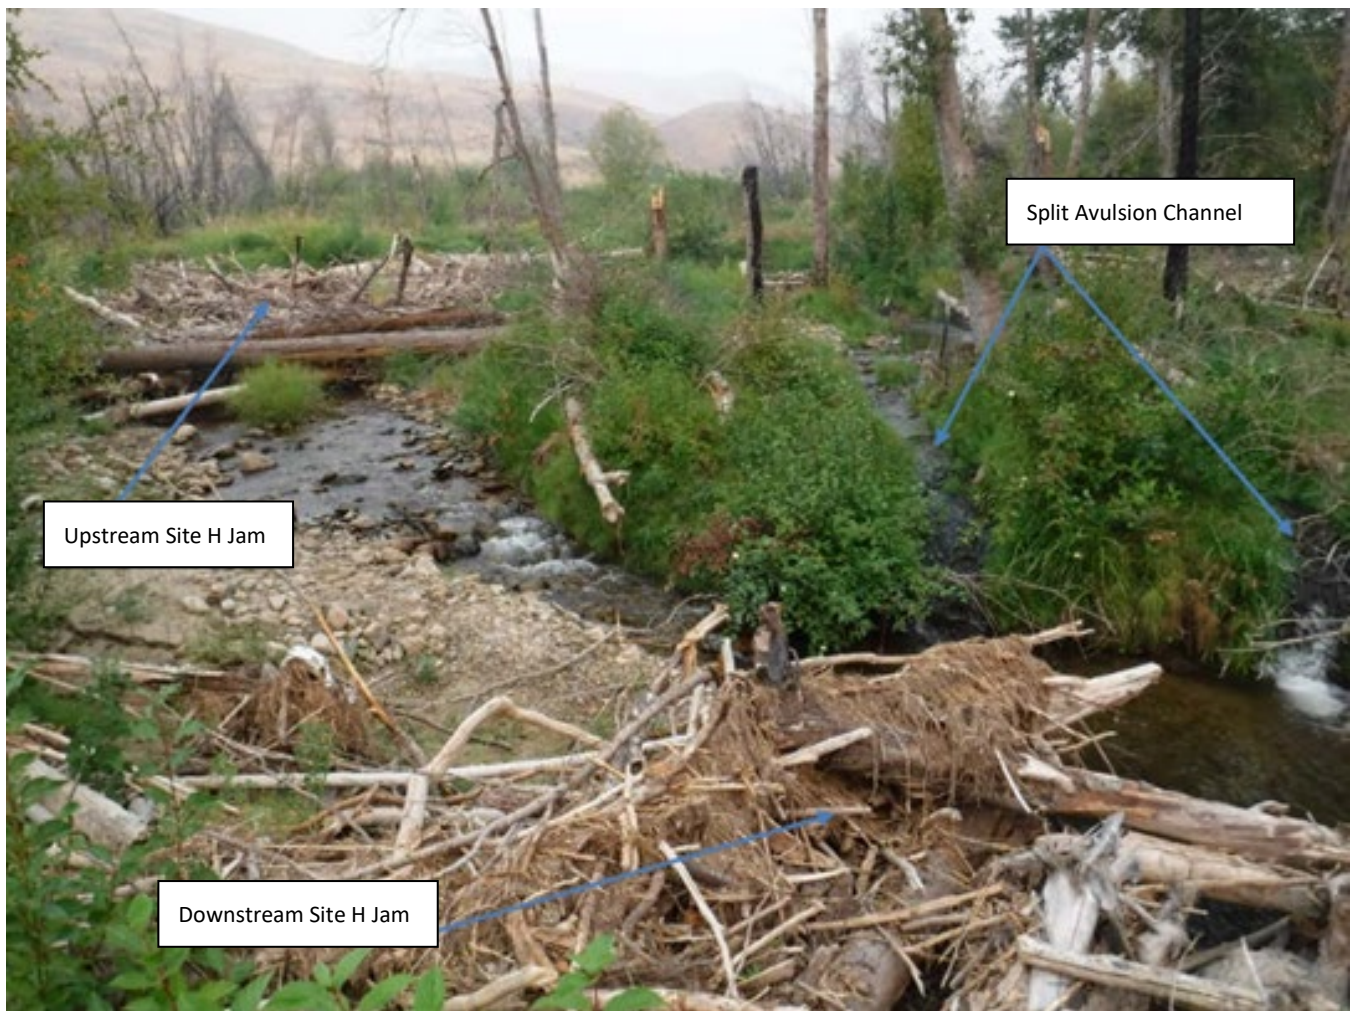
Figure 3-38. Looking upstream at Site H avulsions that developed during the 7.5-year flow event (2017).

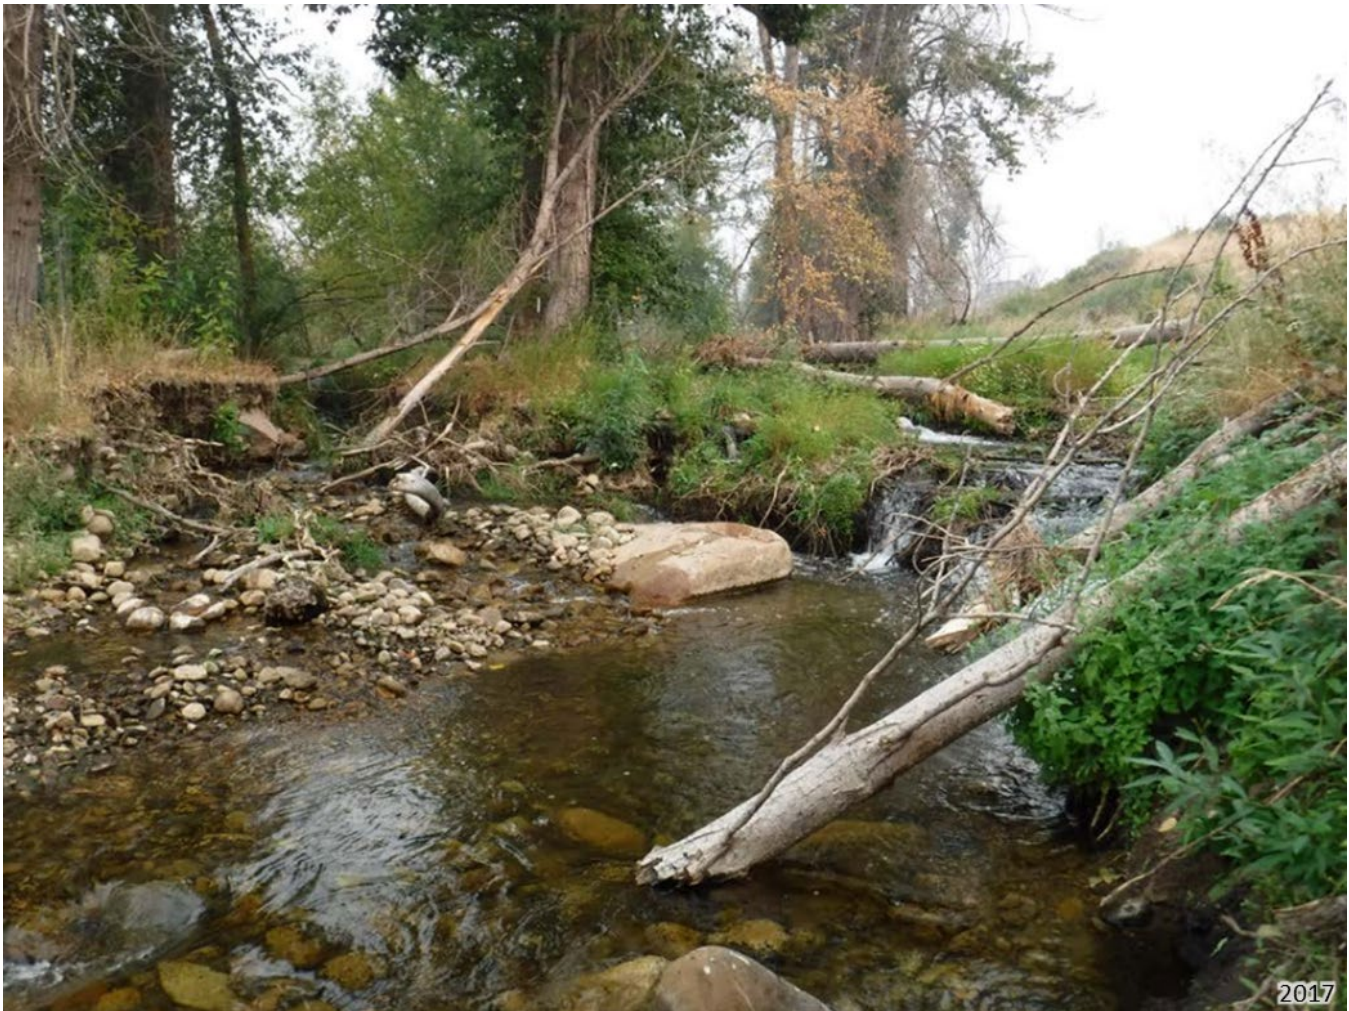
Figure 3-40. Downstream of Site I looking upstream at avulsion pathways that developed from the 7.5-year flow event (2017).

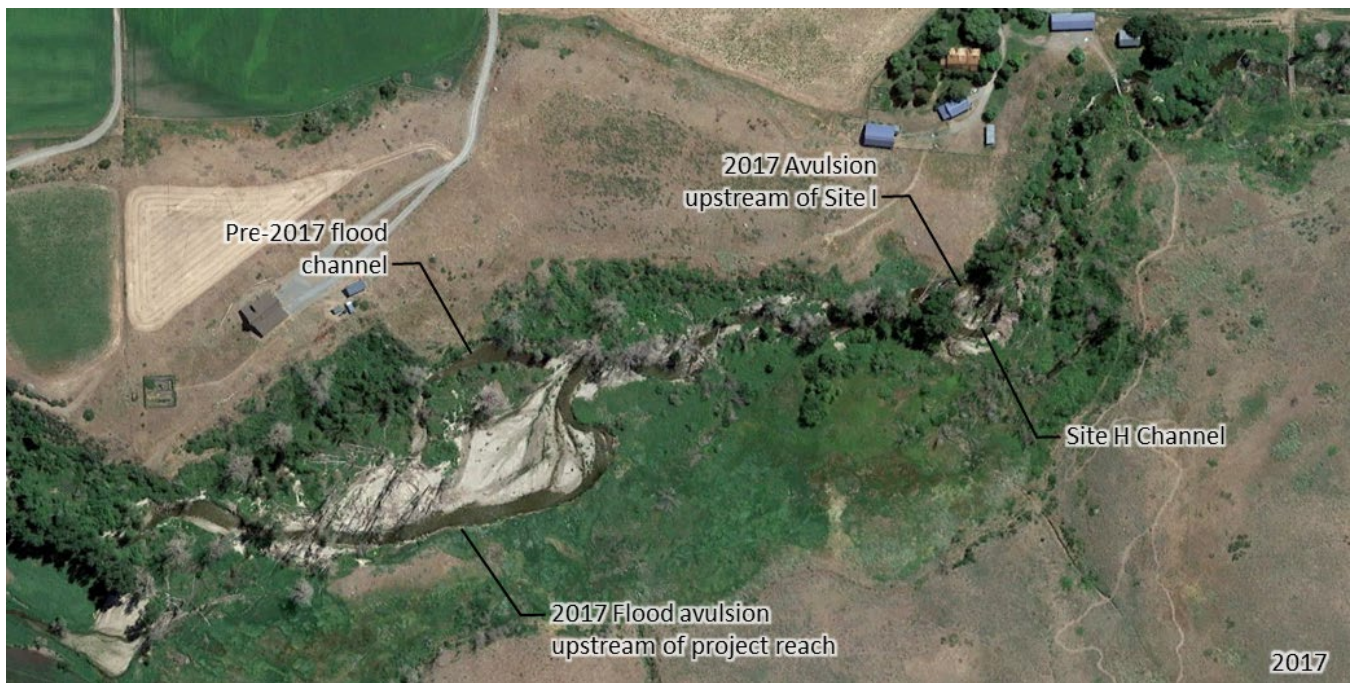
Figure 3-41. Aerial view of 2017 post-flood Beaver Creek channel conditions near Sites H and I.

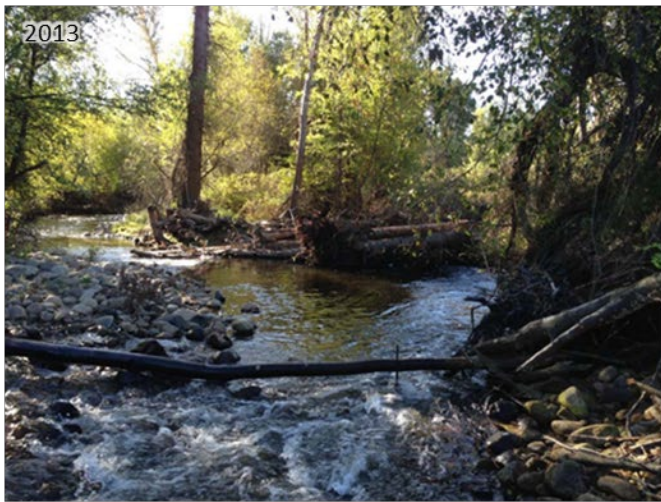
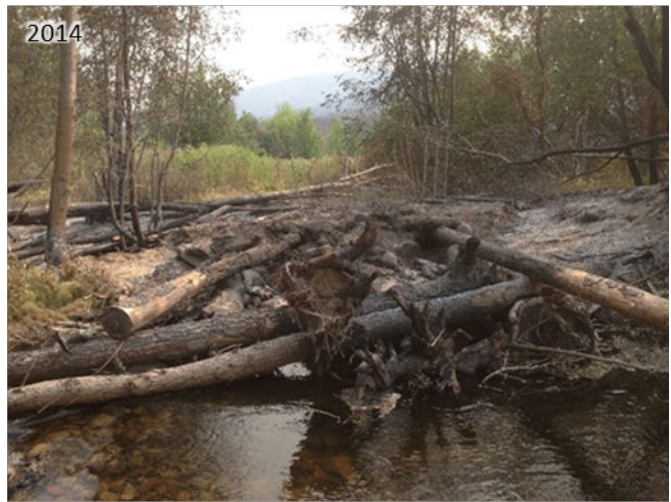
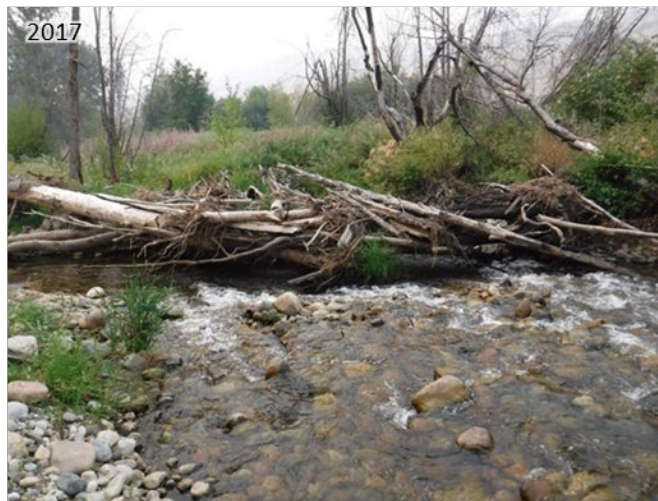
Figure 3-42. Site K Looking at the face of the structure. Upper left: immediately post-construction (2013). Upper right: post-fire, post-5-year flow event (2014). Bottom: post-7.5-year flow event (2017).

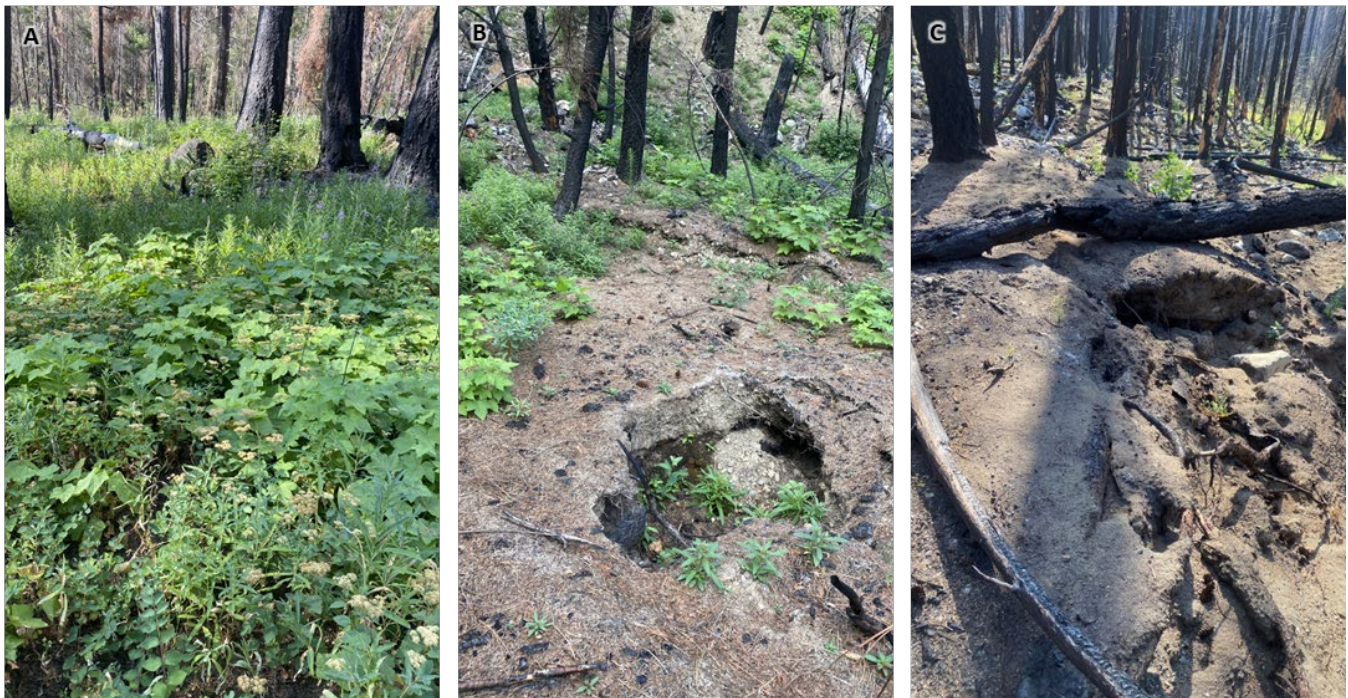
Figure 3-46. Examples of patchy groundcover regeneration that were barren in 2021 at A) low soil burn severity area on floodplain at RM 3.8; B) moderate soil burn severity on floodplain with surface collapse at burned root ground piping at RM 4.5; and C) high soil burn severity on floodplain with surface collapse and soil erosion at burned root ground piping and high ash content at RM 3.41. Photos collected August 11, 2022.

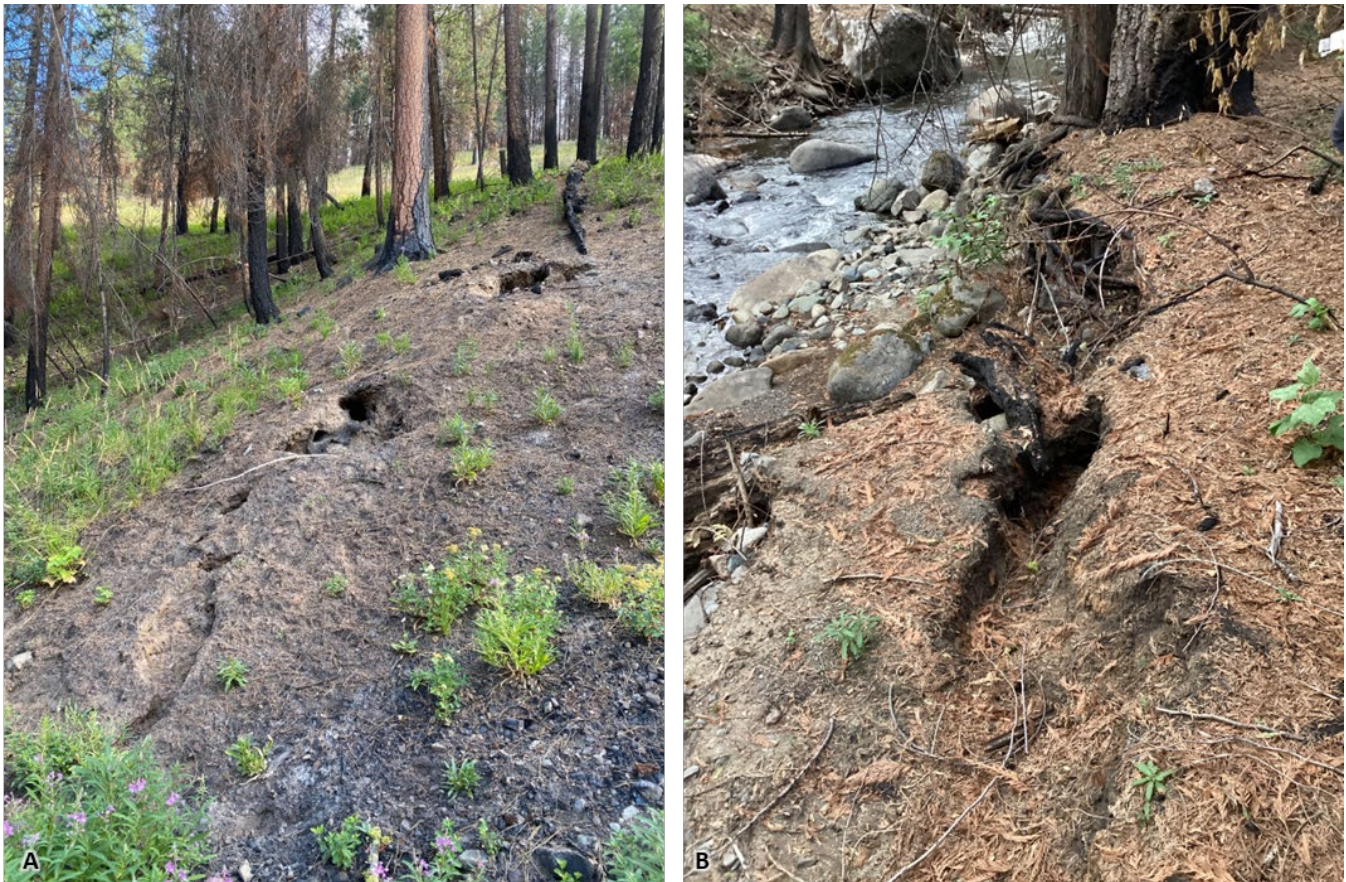
Figure 3-47. Example photos of post-fire soil erosion processes at A) burned root void collapse and piping instigating upslope rill-development on a floodplain terrace at RM 4.08; and B) destabilized bank collapse at RM 4.47. Photos collected August 11, 2022.

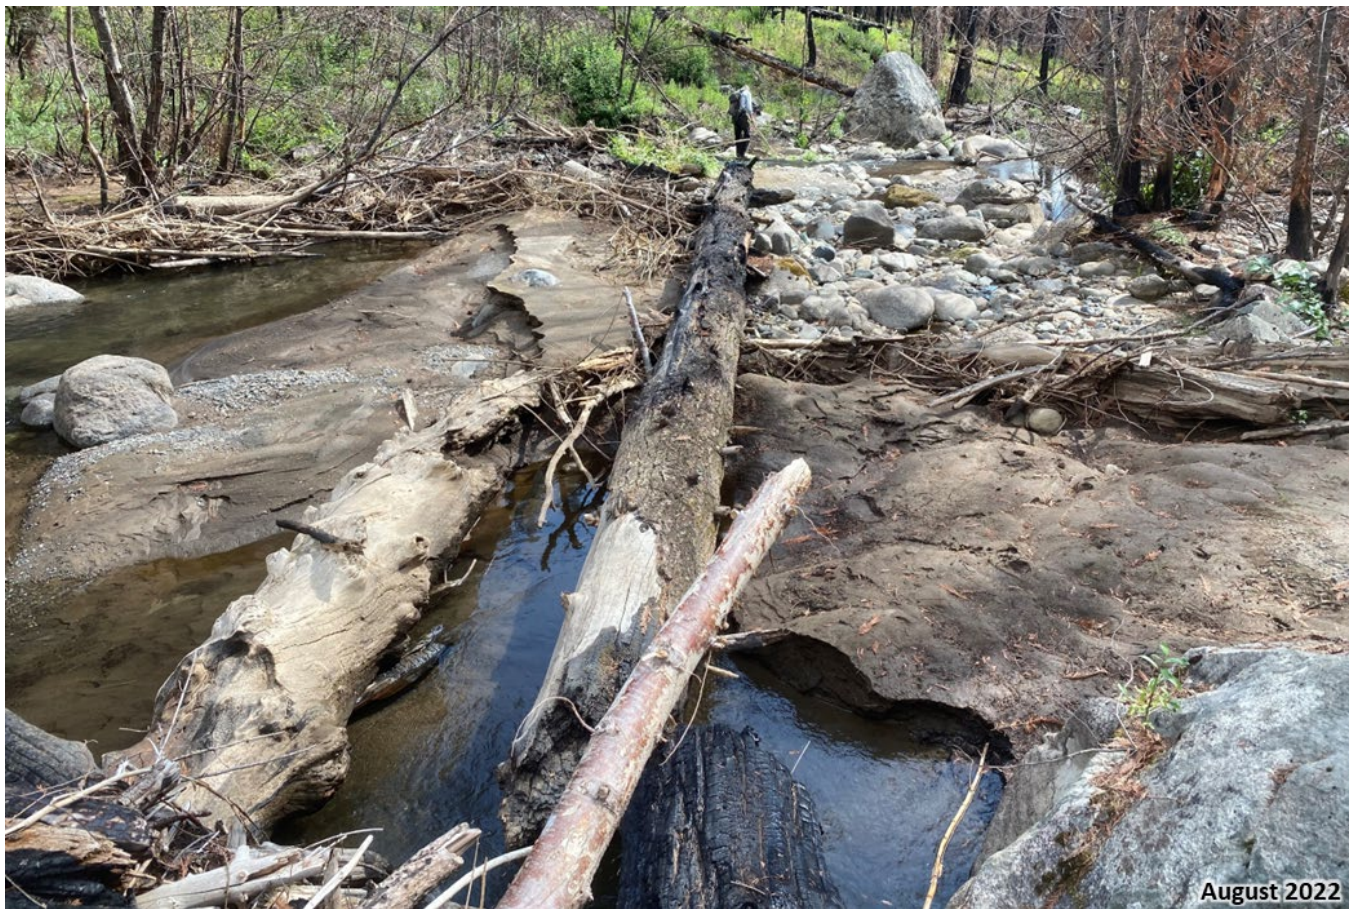
Figure 3-48. Fines accumulated behind large wood and debris at the margin of the channel at RM 3.02. Photo collected August 11, 2022.

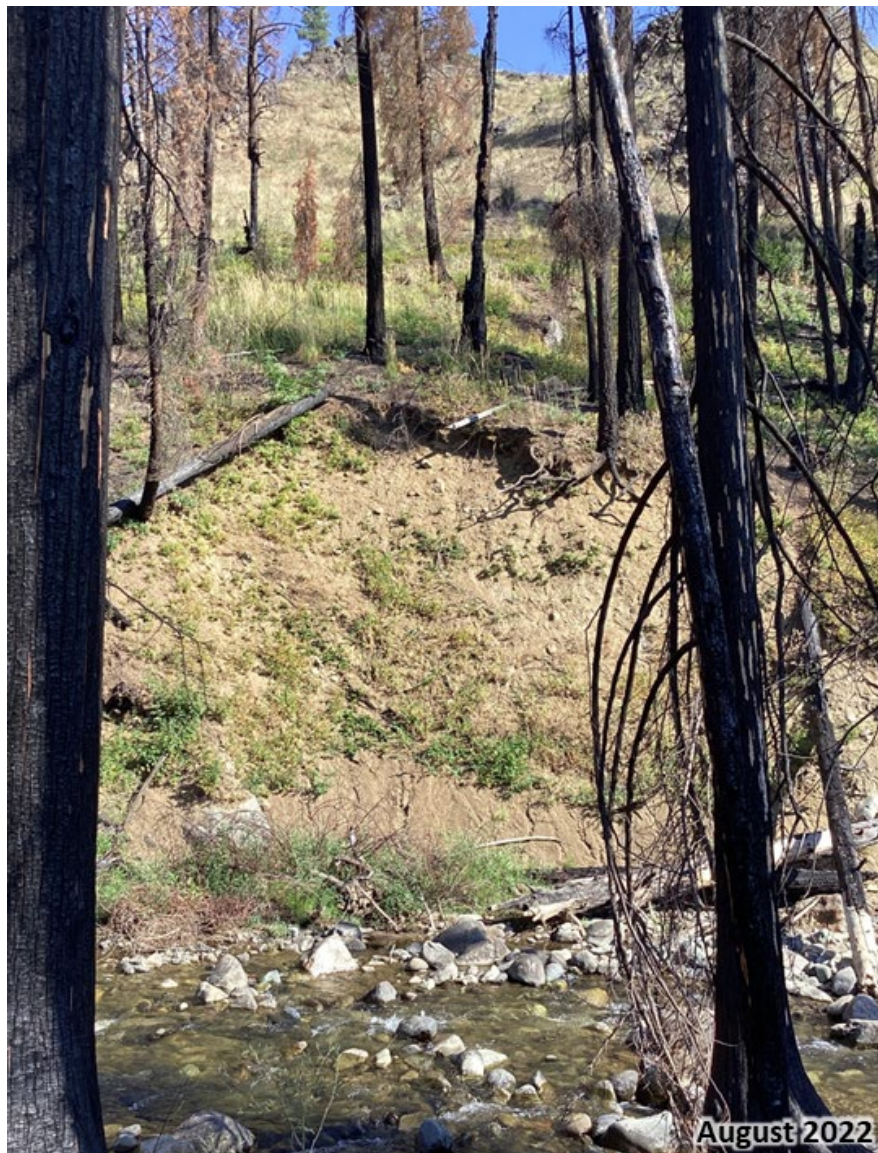
Figure 3-51. Unstable hillslope at R 3.37 on river left – contribution sediment and large wood. Photo taken August 11, 2022.

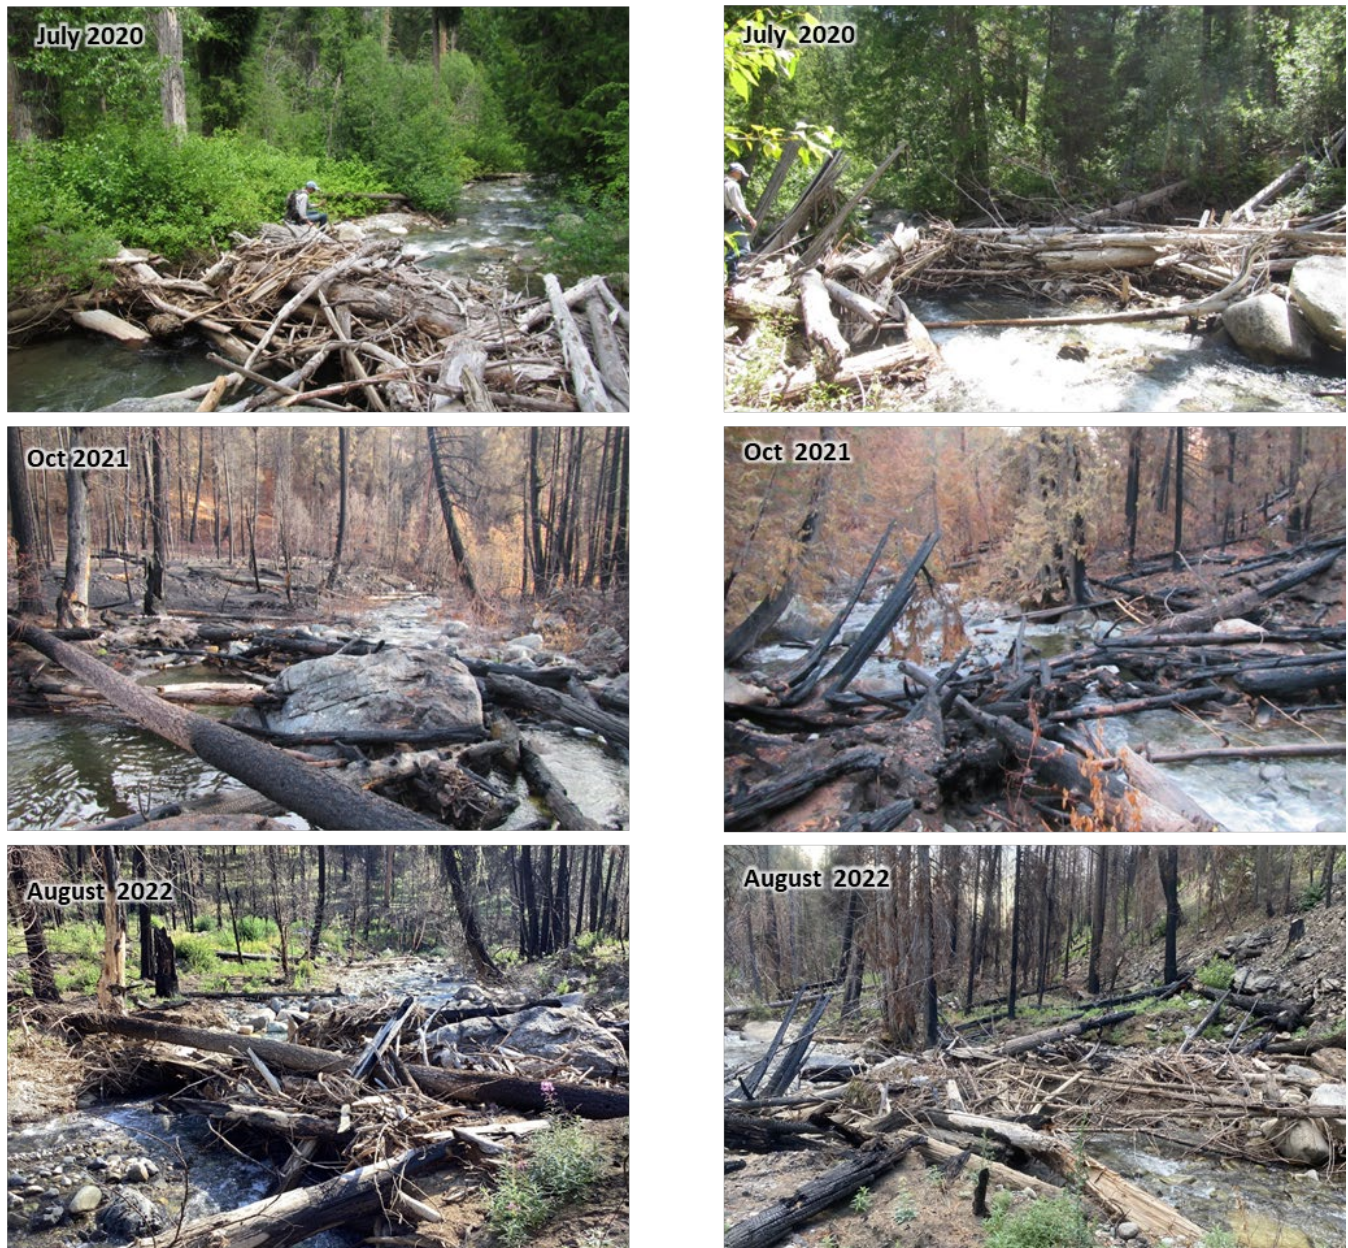
Figure 3-52. Left: channel-spanning large wood jam at RM 3.36 prior to the Cedar Creek Fire (July 2020), the same jam post-fire partially burned (October 2021), and accumulations of small wood 1-year post-fire (August 2022). Right: channel-spanning large wood jam at RM 4.43 prior to the Cedar Creek Fire (July 2020), the same jam post-fire partially burned (October 2021), and accumulations of small wood 1-year post-fire (August 2022).

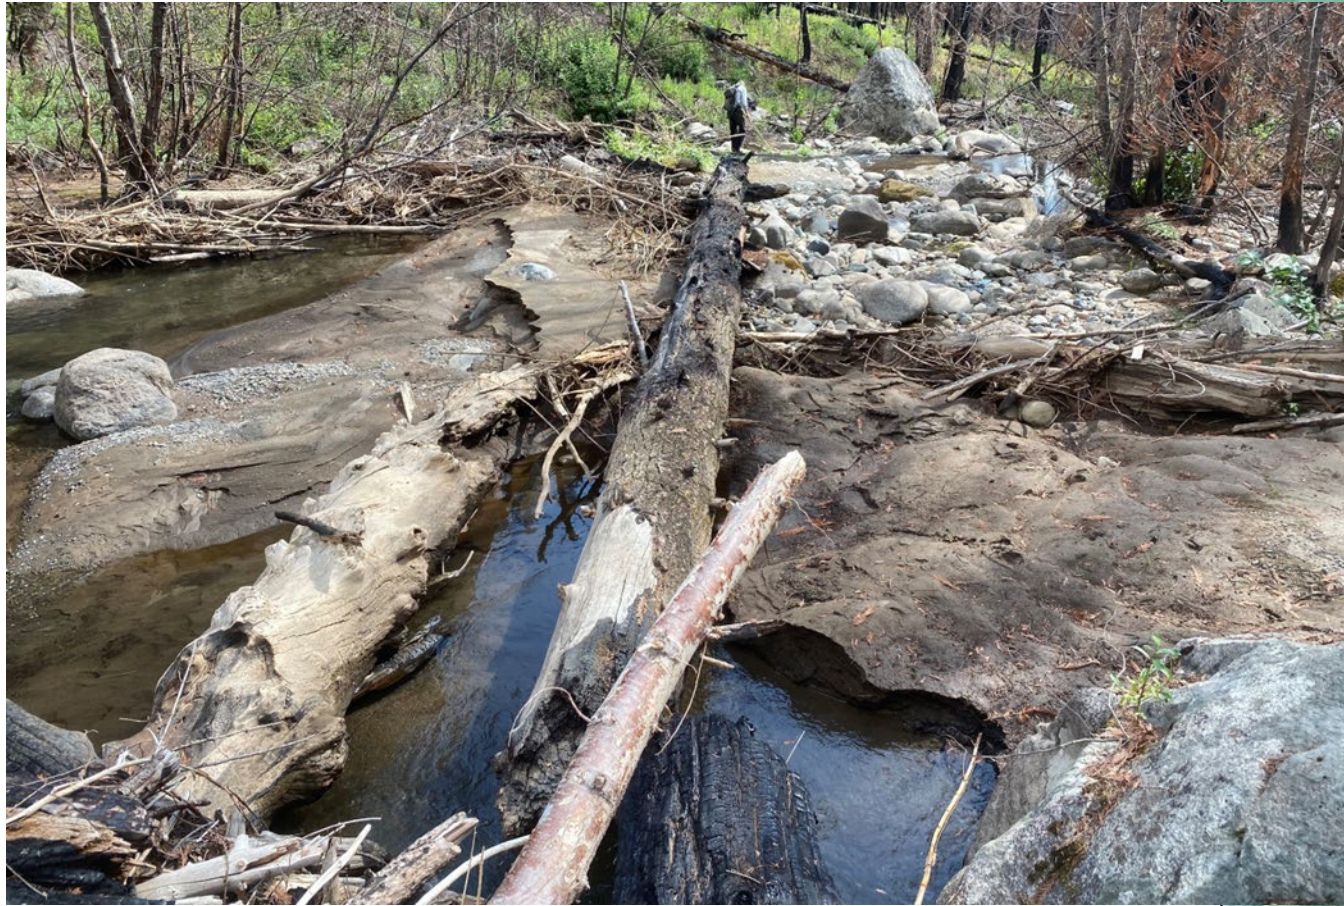
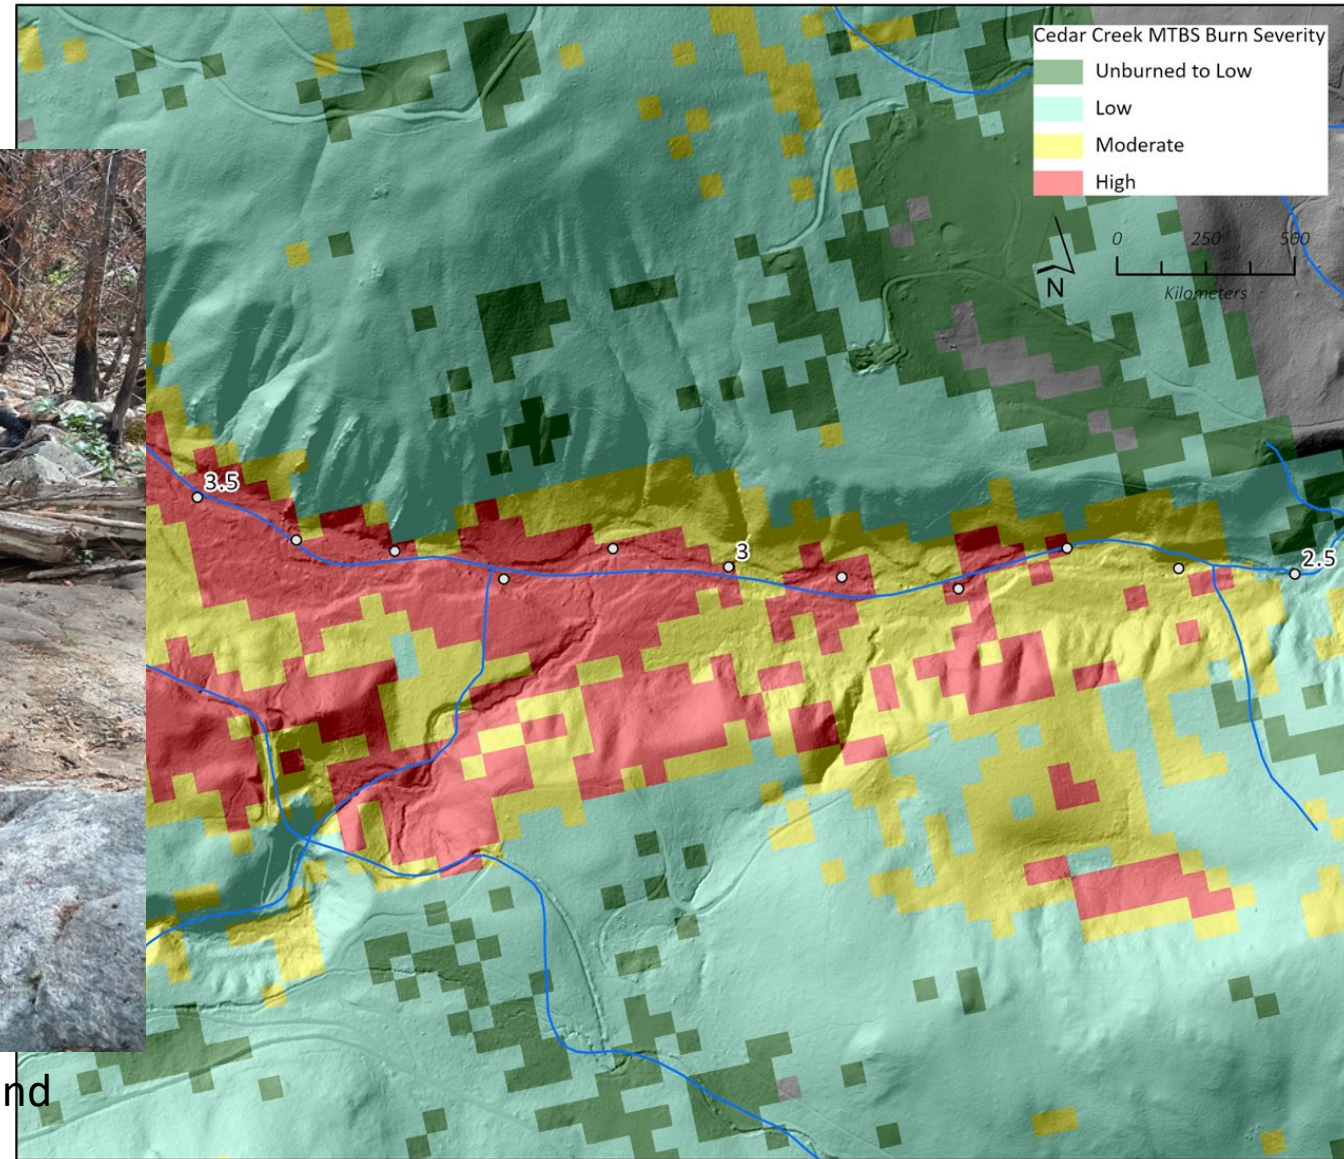
Figure 5. Fines accumulation behind large wood and debris and at the margin of the channel at RM 3.02. (8/11/2022)
