Wildfire and River Restoration: Case Studies from the Methow River Watershed

For U. S. Bureau of Reclamation
July 2023

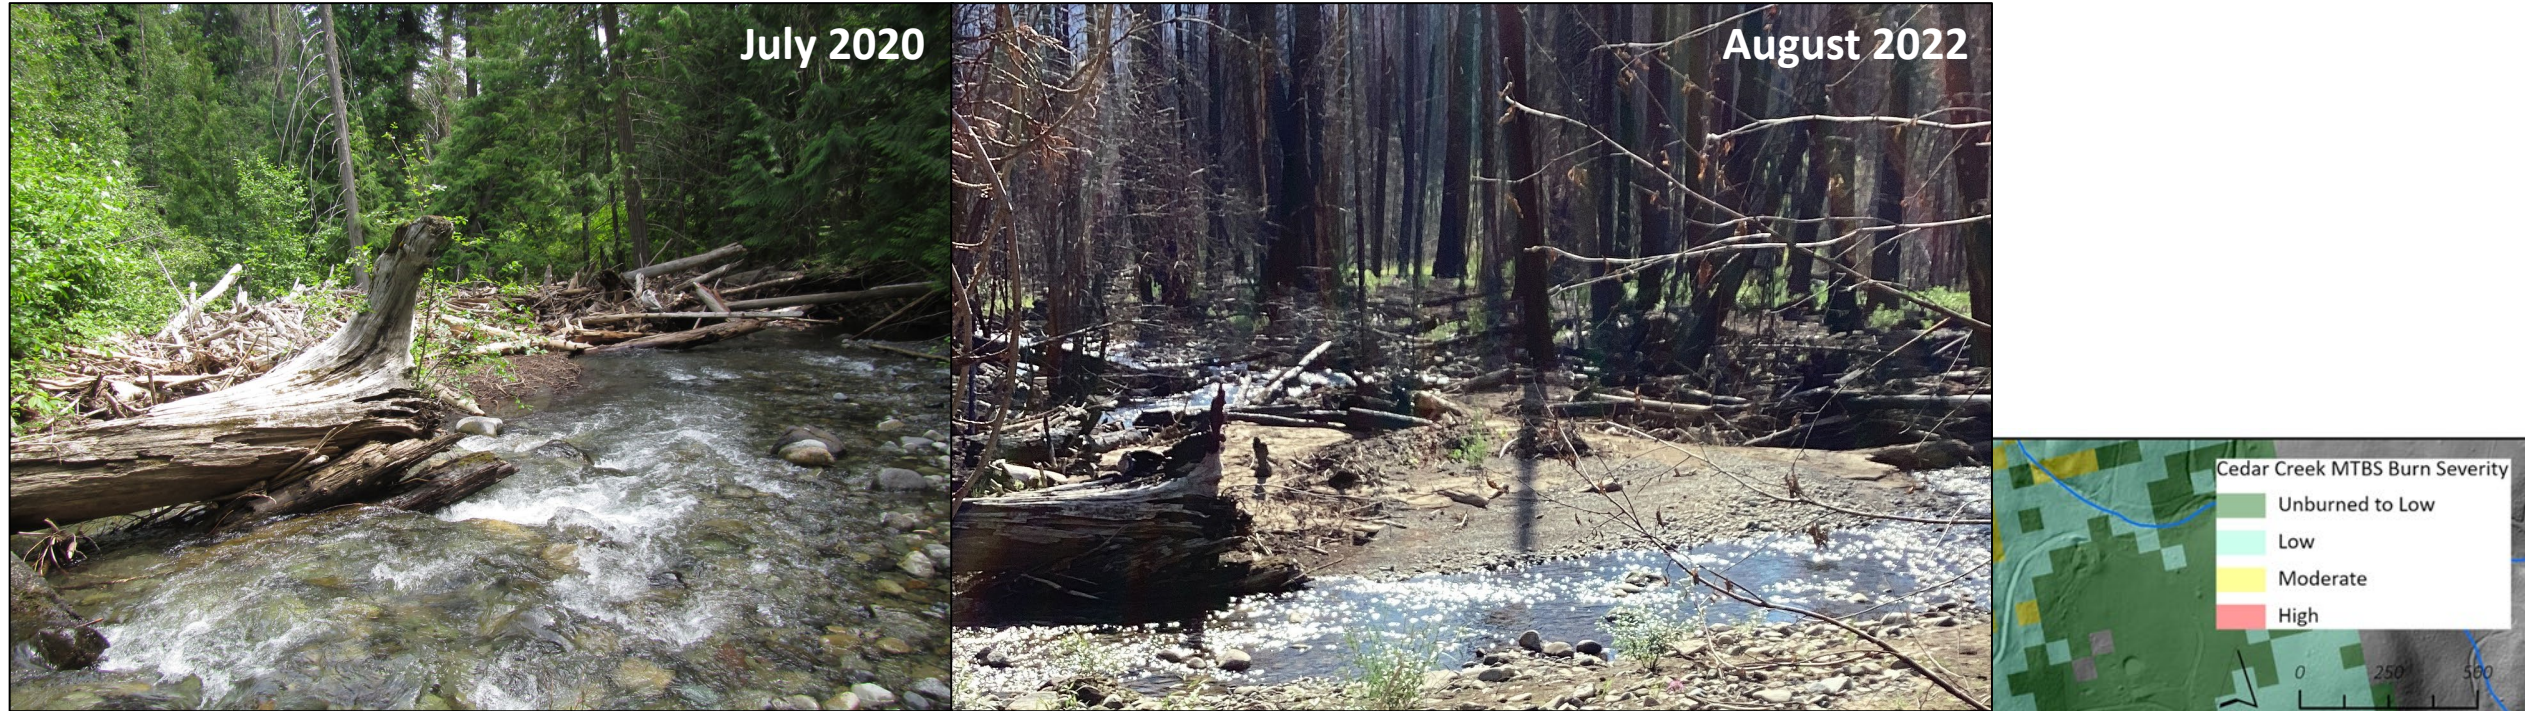
Figure 10. LEFT: looking downstream at channel-spanning large wood channel-spanning jam at RM 3.43 – July 2020. RIGHT looking downstream at RM 3.43 – August 2022.
