WILDFIRE AND RIVER RESTORATION BEAVER CREEK, WASHINGTON

HABITAT RESTORATION

CASE STUDY PURPOSE

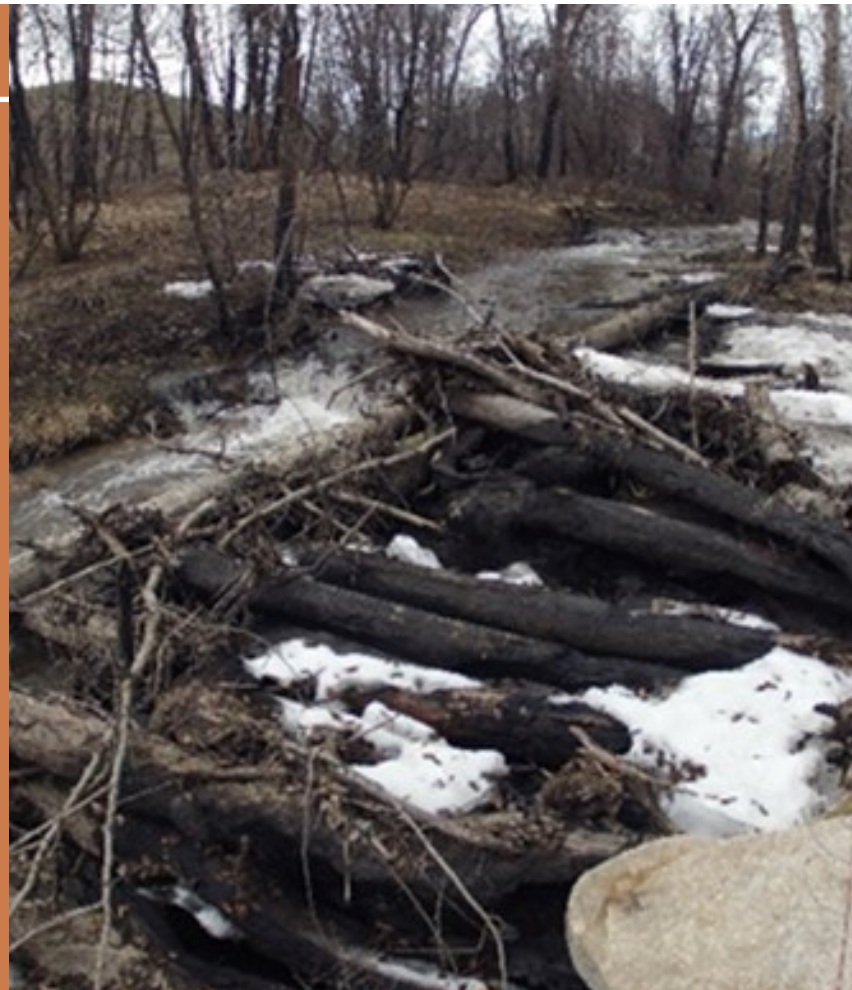
The Carlton Complex Fire burned the recently constructed Schoolhouse Fish Enhancement Project, directly burning some of the constructed log jams and 36% of the contributing watershed. While the fire was still active, a large rainstorm in August 2014 caused a 5-year flow event on Beaver Creek at the Schoolhouse site and triggered numerous debris flows into drainages that feed into Beaver Creek and resulted in exceptionally high sediment loading in the project site. Another storm in 2017 resulted in flows that were likely amplified by the burned condition of the watershed. The event caused substantial channel migration and avulsion.

The direct and indirect effects of the Carlton Complex Fire that were observed at the project site include:

- Burned riparian area, including native and planted vegetation (Sites B, C, D, E, K, and H)
- Post-fire sediment loading and channel avulsion (Sites A, H, and I)
- Burned log jam structures (Sites C, D, E, and K)
- Post-fire slash accumulation at all project sites

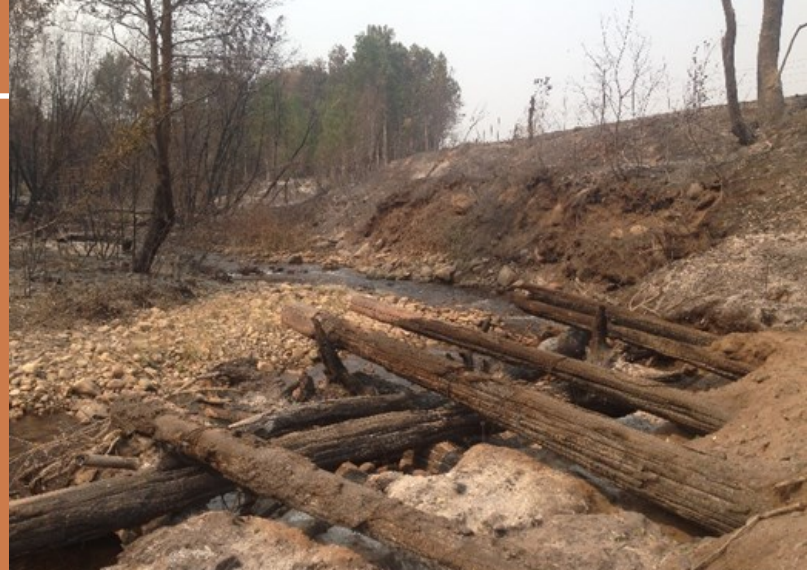
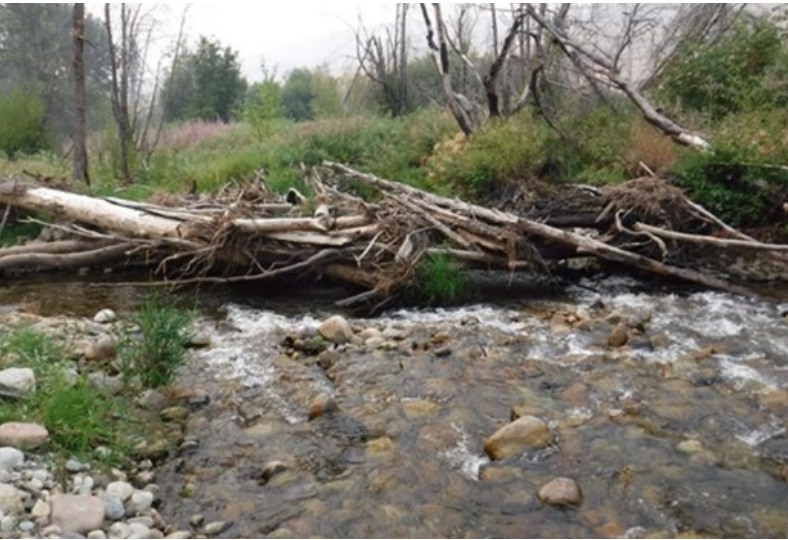
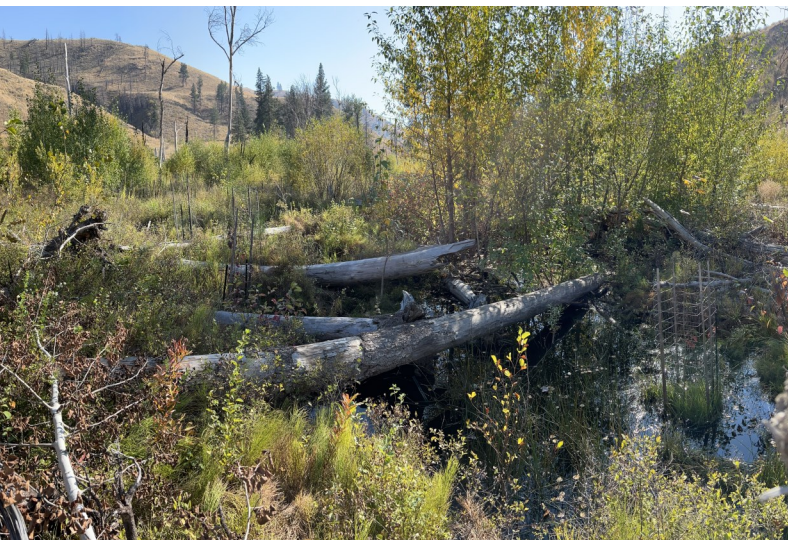
Post-fire processes observed in 2014 at restoration sites where the subreach bed and banks were flatter, less efficient at sediment transport, and composed of alluvial deposits were seen again in 2017, indicating that these channel segments may be more vulnerable to channel expansion or avulsion. Restoration sites with channel boundaries partially composed of boulder lag deposits, steeper channel slopes, and excess sediment transport capacity were more stable and resilient to post-fire sediment loads and adjacent riparian burn.

- While large diameter wood in large wood structures was burned, enough remained after the fire to maintain structural integrity, provide bed scour, and collect post-fire slash that restored burned cover habitat
- Structures that projected well into the channel and at low elevation were more resistant to fire
- Structures in steeper reaches with boulder lag deposits were more resilient to elevated post-fire sediment loads and recovered habitat function by collecting slash to replace wood lost to fire
- Dynamic channel responses can be expected in the first few years post-fire; structures in depositional reaches of fire-prone project are more likely to become buried or abandoned
- Areas with broad valley bottoms, low elevation floodplains, and robust riparian communities can be expected to burn less severely and regenerate quickly.
