Wildfire and River Restoration: Case Studies from the Methow River Watershed

For U. S. Bureau of Reclamation
July 2023

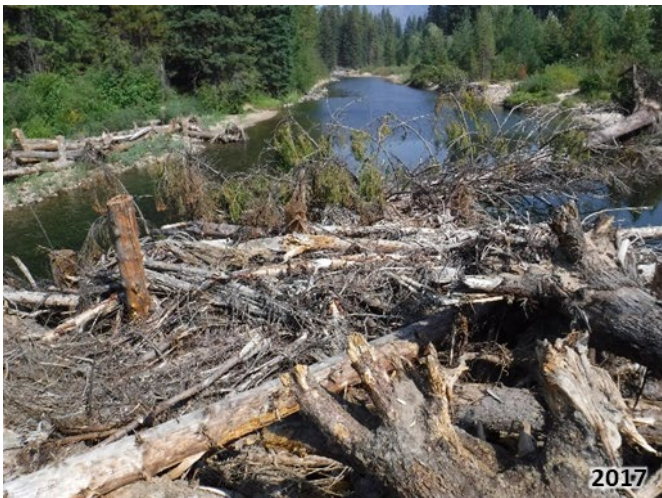
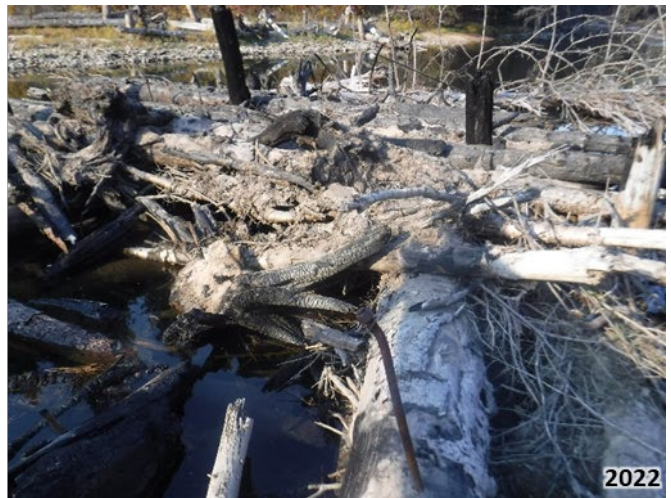
Figure 3-11. Photos of Site B. Left is pre-fire, right is post-fire.

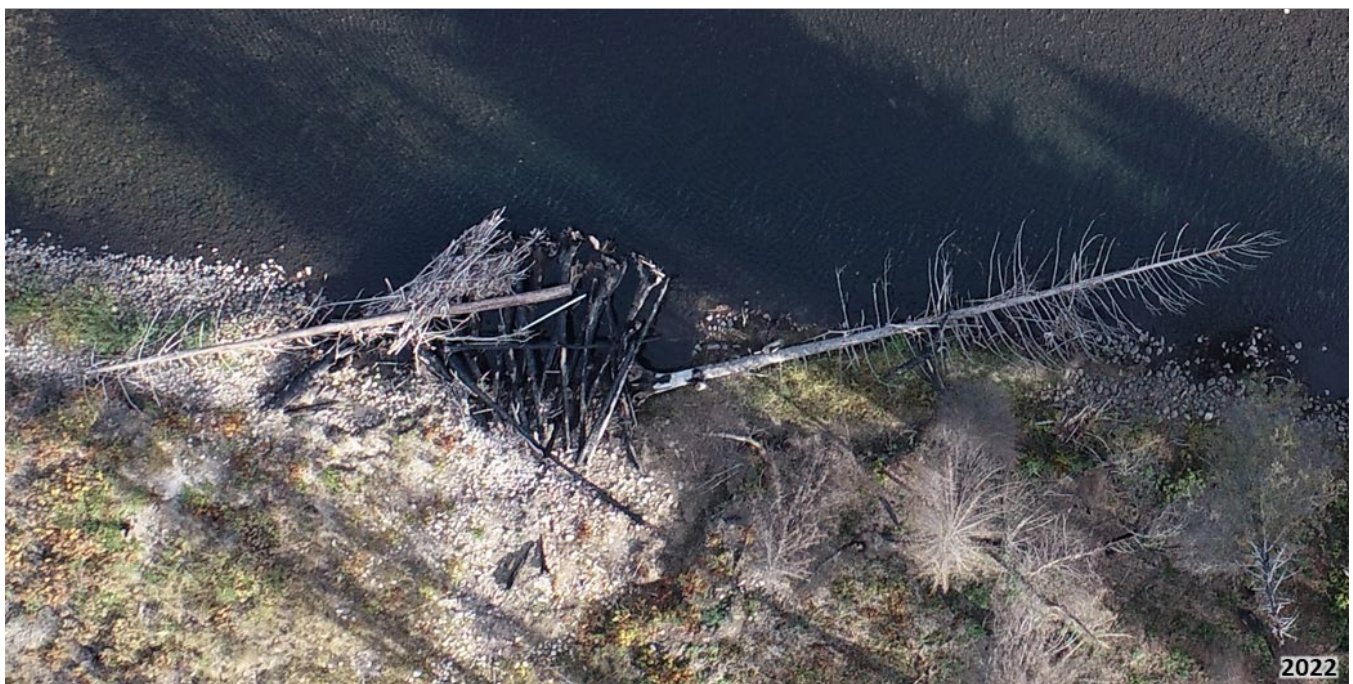
Figure 3-16. Overview of Site J pre-fire (top) and post-fire (bottom). Flow is left to right.

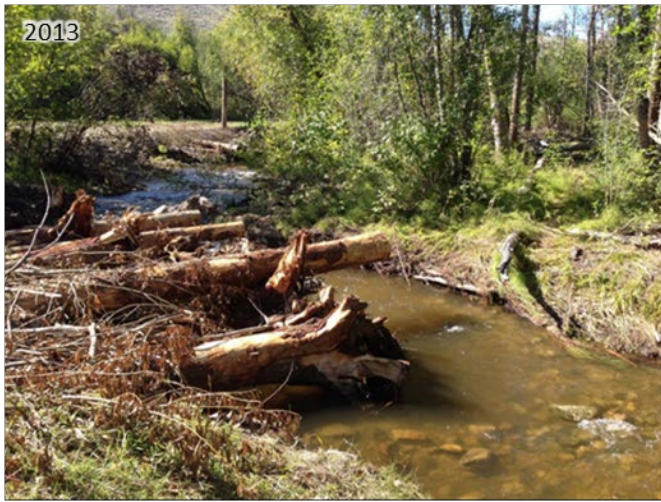
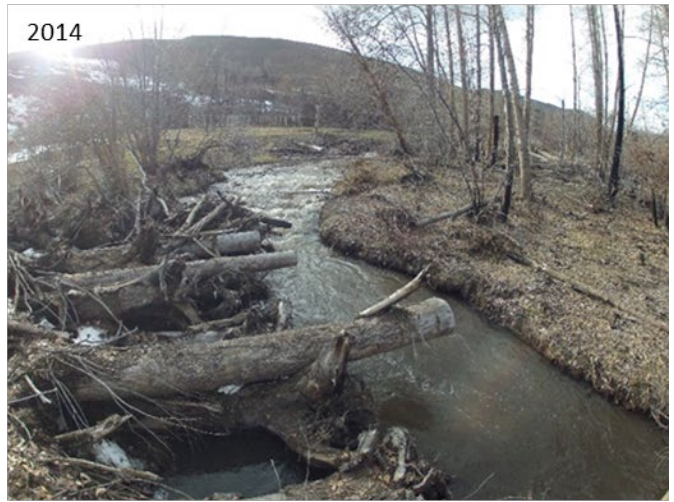
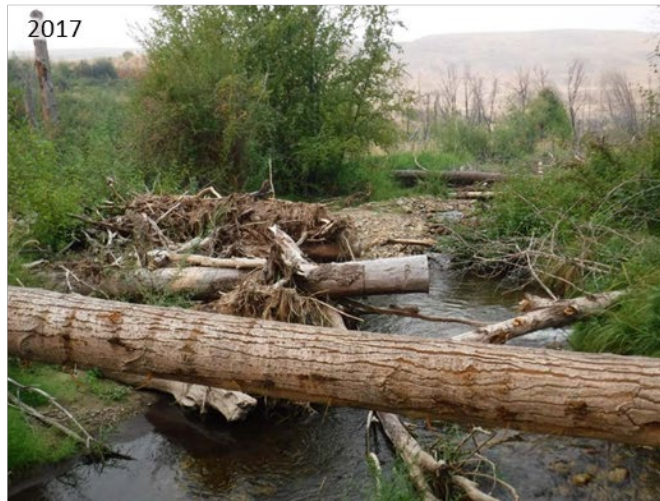
Site H restored a historic channel alignment with greater channel length. Two right-bank-buried wood structures were constructed in the re-watered channel to enhance rearing habitat, spawning gravel, and adult holding. The previous straighter, down-valley channel was filled with large wood and substrate at the upstream end and allowed to function as a backwater habitat at the downstream end where the old and re-watered channels met. Site H did not significantly change after the fire and 2014 flood. However, beavers were actively felling cottonwood trees and adding material to the channel in the years following the fire. Small avulsion channels were developing from 2014 flood flow slash deposits at the upstream bank-buried wood structure but remained static from 2014 post-flood conditions up until 2017. An estimated 7.5-year flow event occurred in 2017. During this flow, significant slash accumulation and sediment deposition occurred upstream of two bank-buried wood structures. The wood and sediment backwatered flows and caused the development of an avulsion channel against the left (east) valley terrace, resulting in a channel with significantly less length and steeper slope.

Figure 3-37. Downstream jam of Site H looking upstream. Upper left: immediately post-construction (2013). Upper right: post-fire, post-5-year flow event (2014). Bottom: post-7.5-year flow event (2017).

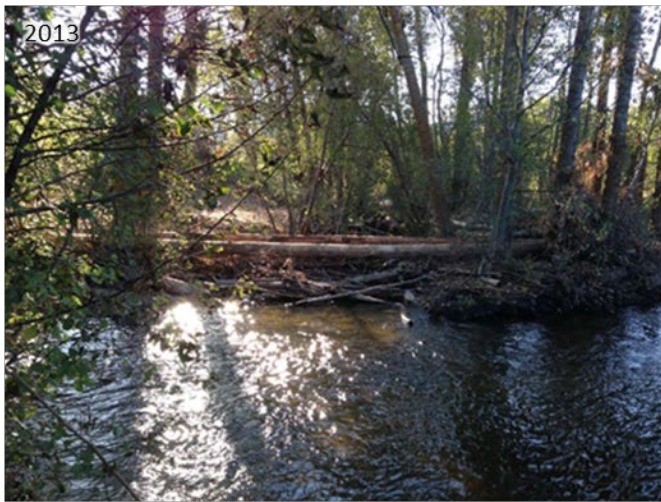
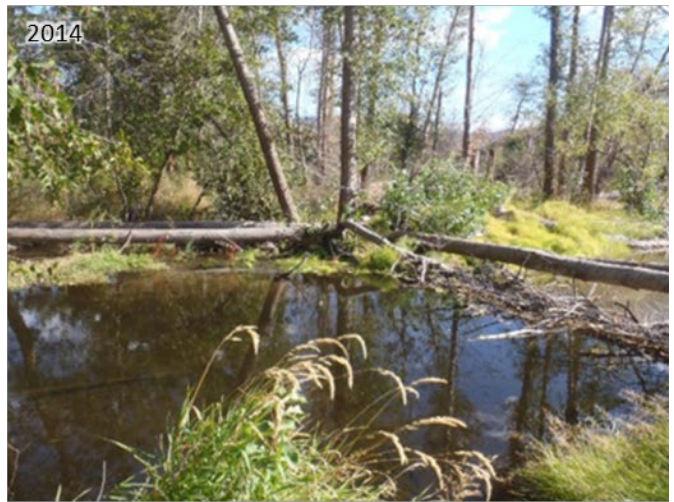
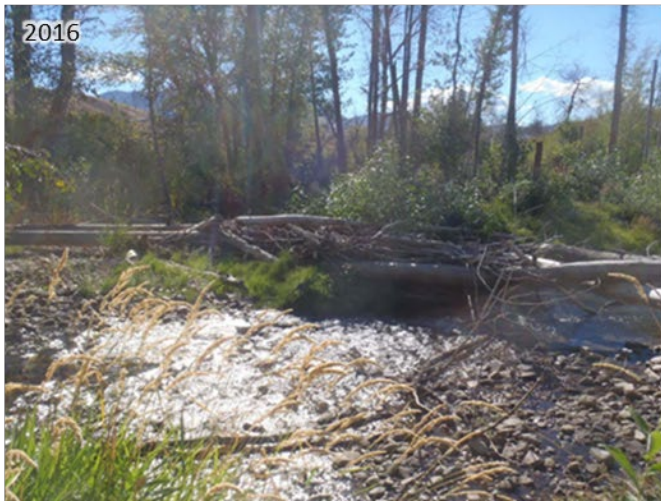
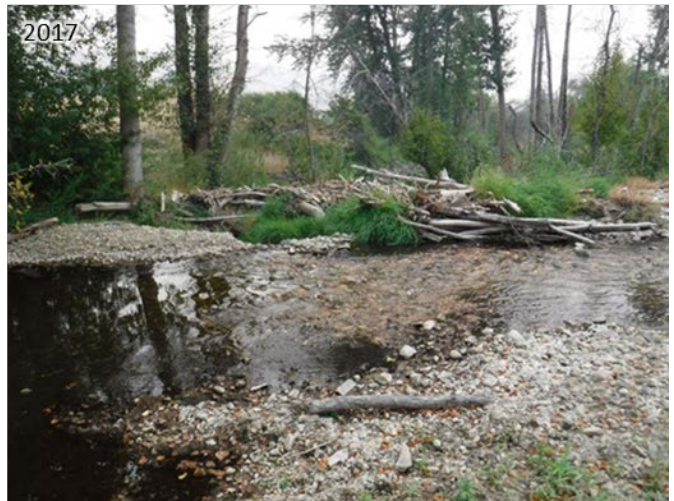
Site I filled a straighter, down-valley channel to enable Site H—a historic, longer channel—to exist. After the fire and 2014 flow event, Site I was functioning as designed. The channel fill was excluding flow from the pre-project channel. In 2015, a beaver dammed the main channel with a 3ft high dam, as shown in Figure 3-39. This dam reduced flow on the main channel down to about 50% of the total flow and forced about 50% of the flow across the former floodplain and channel that Site I was designed to seal off. In 2016 the beaver dam washed away, which resulted in the majority of flow returning to the main channel as designed. The 2017 flood resulted in the development of an avulsion channel upstream of the Site I channel. This new channel ran adjacent to the valley terrace and re-entered Site I (old channel) halfway to the Site H channel confluence. During low flow the channel limited upstream salmonid passage and was modified to allow upstream passage more easily in 2018.

Figure 3-39. Site I looking downstream at the face. Upper left: immediately post-construction (2013). Upper right: beaver dam activity on the main channel (2015). Lower left: beaver dam washed away (2016). Lower right: post-7.5-year flow event (2017).

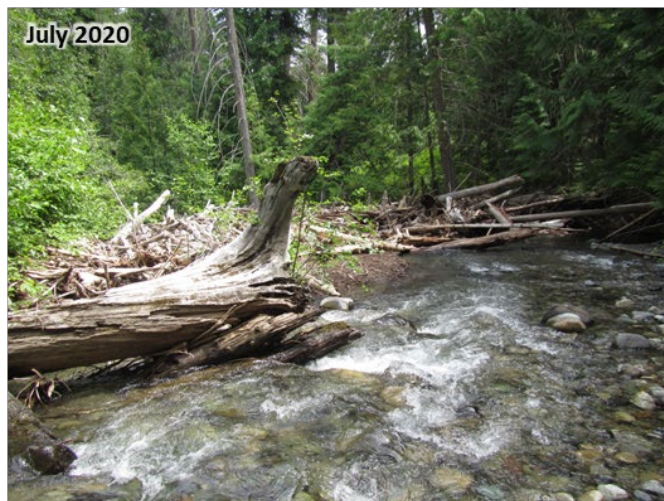
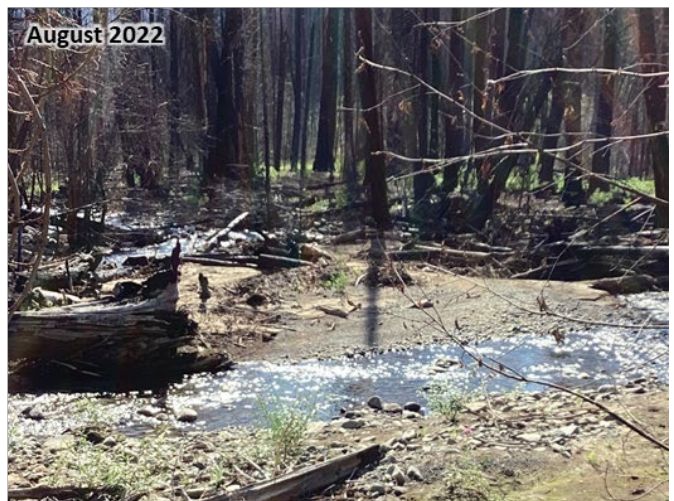
Channel form and post-fire processes were evaluated and noted during the 2022 field survey. Minimal changes to channel form occurred within the project area compared to 2021 and 2020 conditions. Bank erosion associated with subtle channel widening was observed in localized areas where bank/hillslope failure occurred, usually associated with areas of burn-related riparian vegetation loss and where burned-out log structures decreased in-channel complexity. As predicted, increased erosion processes in the first year produced and transported fines and ash from the adjacent unvegetated surfaces into the channel. Alluvial accumulations of fines (silt and fine sand) rich in ash (clay content) were observed in low flow-velocity areas coating the channel bed, creating new bars, topping existing bars and channel margins, and behind wood and debris accumulations as shown in Figure 3-48 and Figure 3-49. It was observed that salmonid and general aquatic habitat conditions (i.e., gravels coating and embedding) were negatively impacted in the study area by the first year of erosion response (Figure 3-50). The presence of new fines was related to proximity to source and low-flow hydraulic opportunities in the channel. The presence of fines in the channel decreased downstream of the burn boundary.

Figure 3-49. Fine sediment accumulation and bar deposition within the channel.

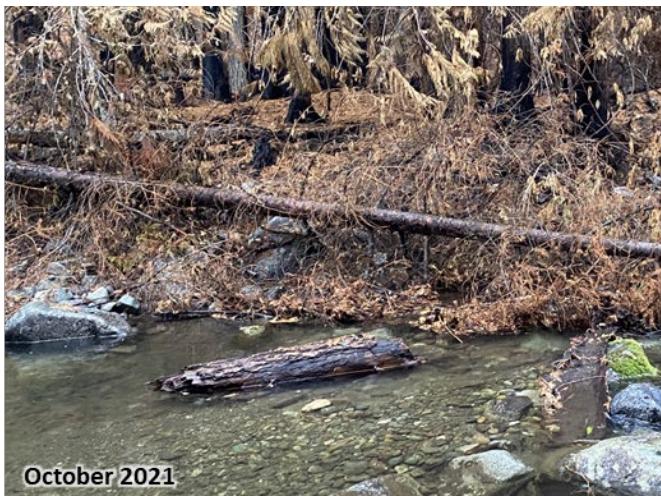
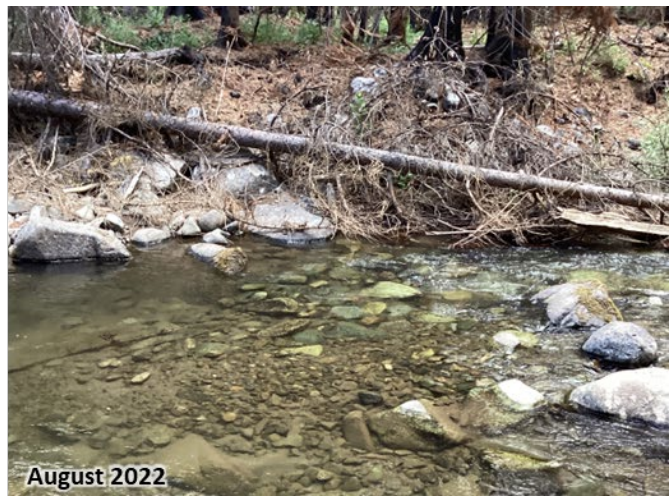
Figure 3-50. Photo of redd at RM 4.34 in 2021 (left) with clean gravels and channel bed and 2022 photo (right) of the same redd coated with silts and fines.
